**HISTORICAL AGRICULTURE
AND SOIL EROSION IN THE
UPPER MISSISSIPPI
VALLEY
HILL COUNTRY**

STANLEY W. TRIMBLE

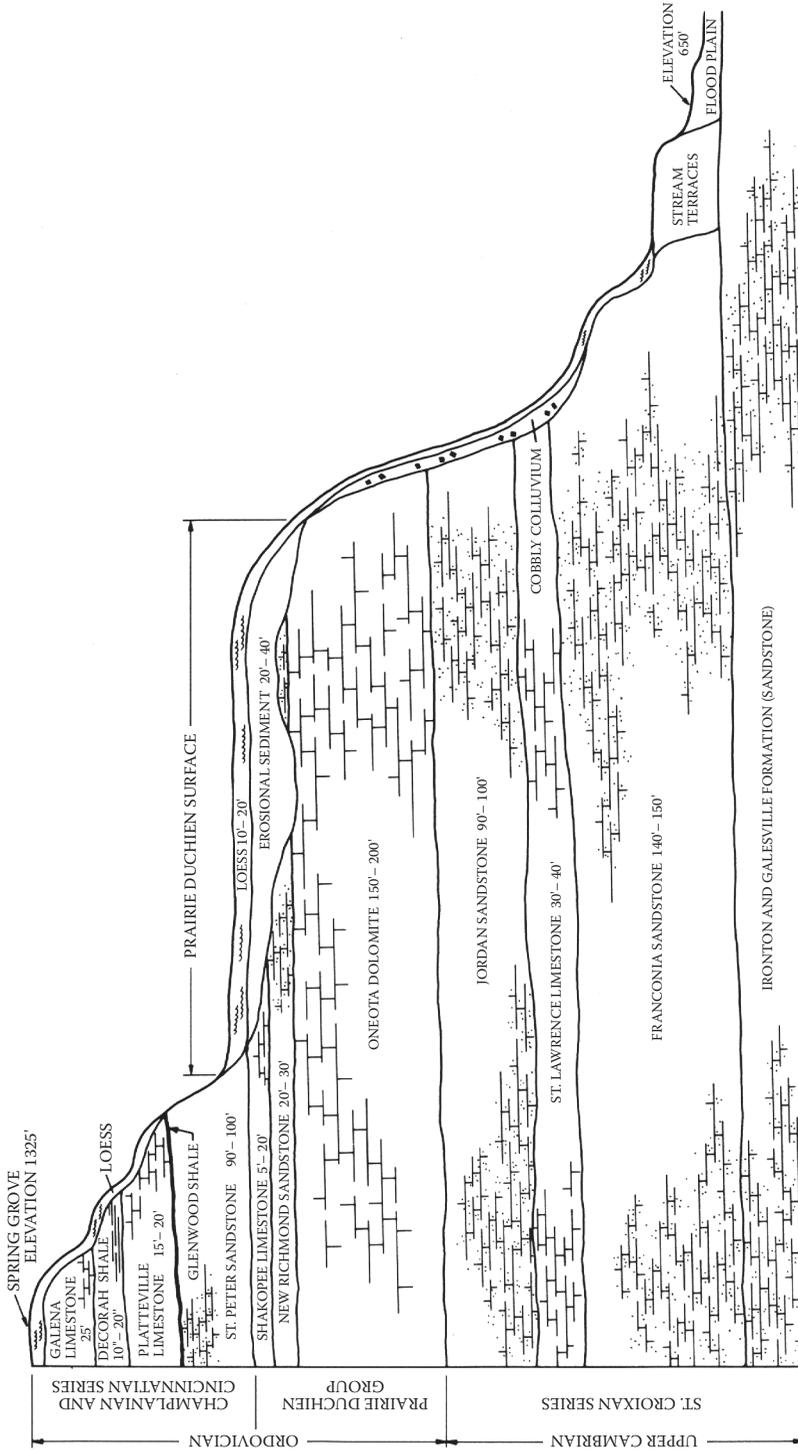
Figure 1.2 Geologic cross section of Houston County, MN, drawn in a west to east direction. (USDA, NRCS, Soil Survey of Houston County, Minnesota, 1984.)

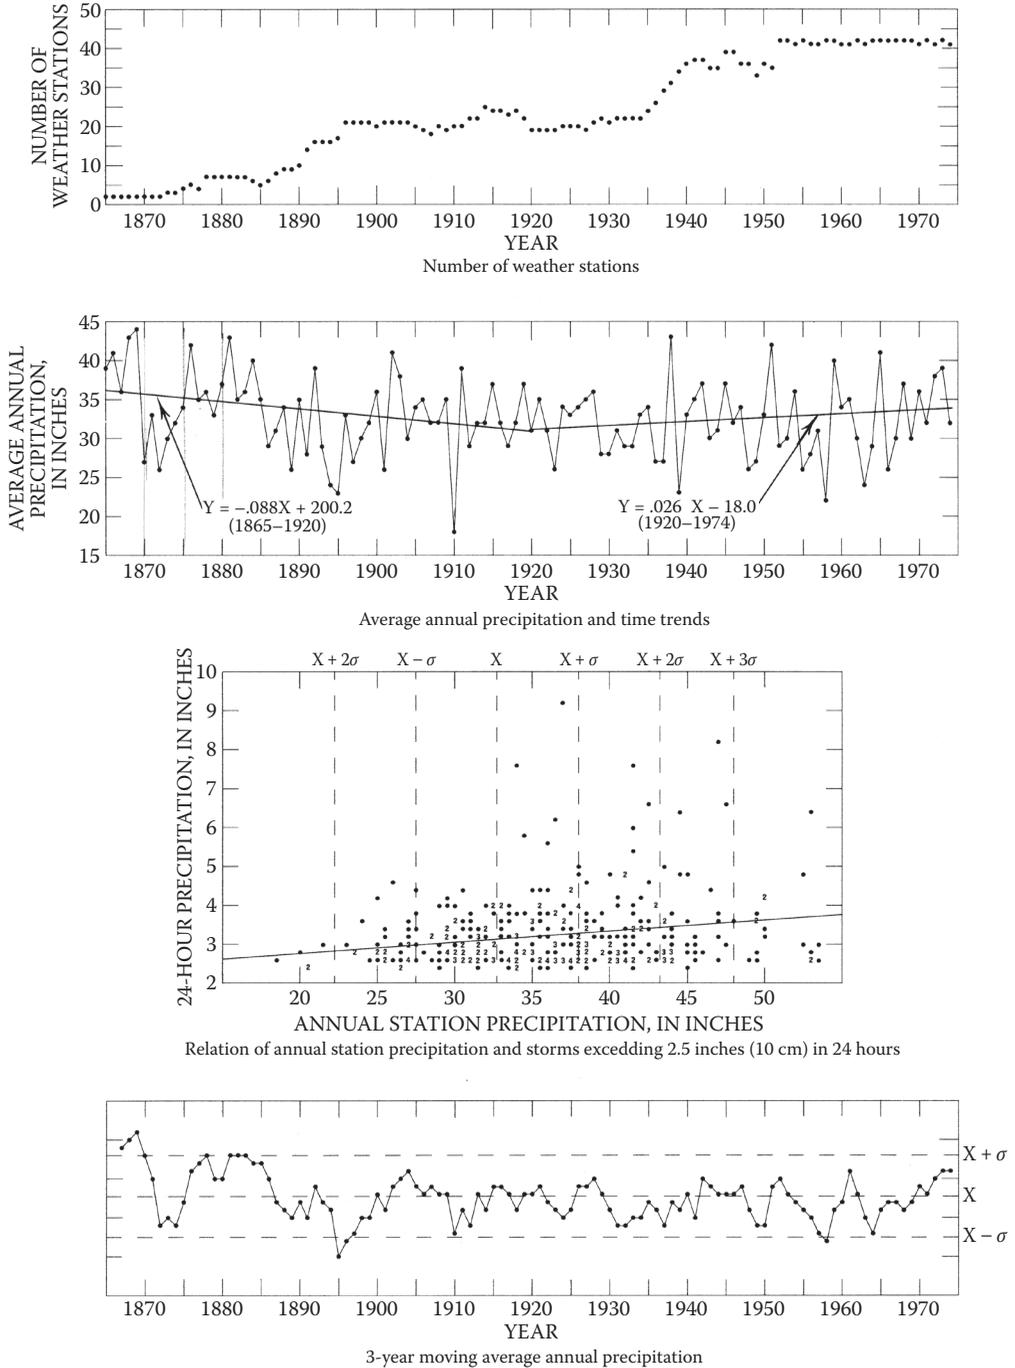
Figure 1.7 Historical precipitation trends in the Hill Country (from Trimble, S., and Lund, S., *US Geol. Surv. Prof. Paper*. 1243, 1982). The data show a nadir of precipitation in the early 20th century and increasing wetness and storms since 1930. See also the annual flood series for the Upper Mississippi River for the period c. 1850-1975, which shows a similar pattern (Knox et al., 1975). (Continued)

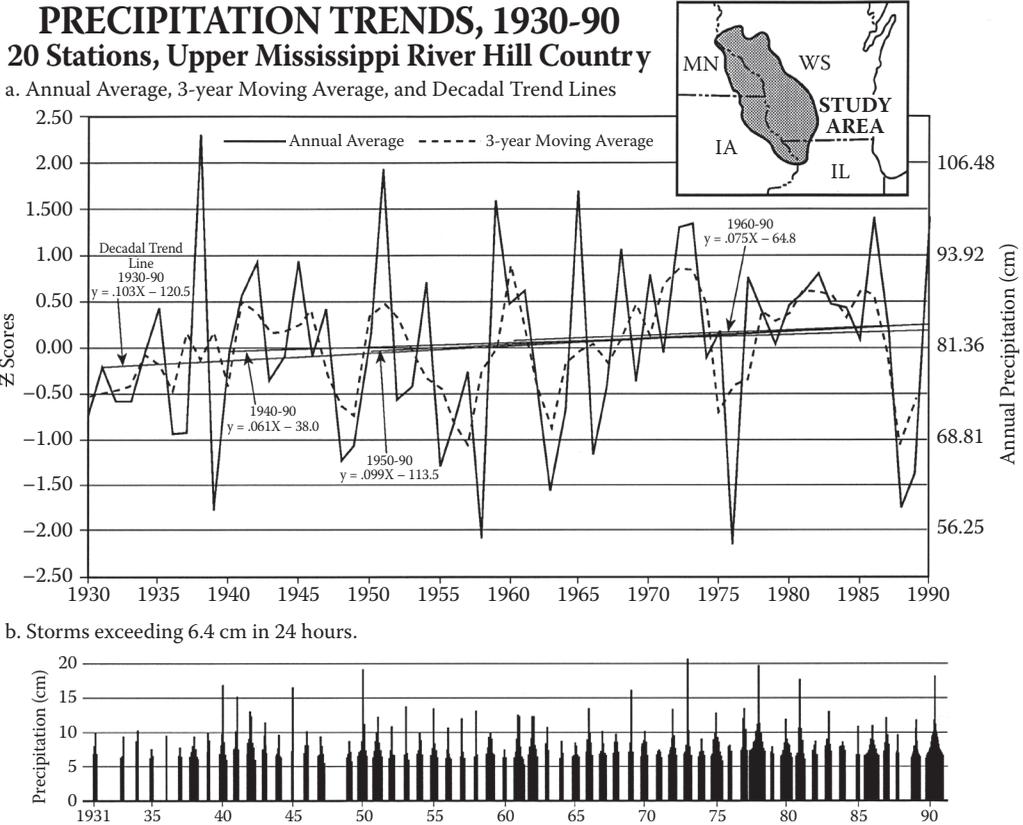
Figure 1.7 (Continued) Historical precipitation trends in the Hill Country (Trimble, unpublished). The data show a nadir of precipitation in the early 20th century and increasing wetness and storms since 1930.

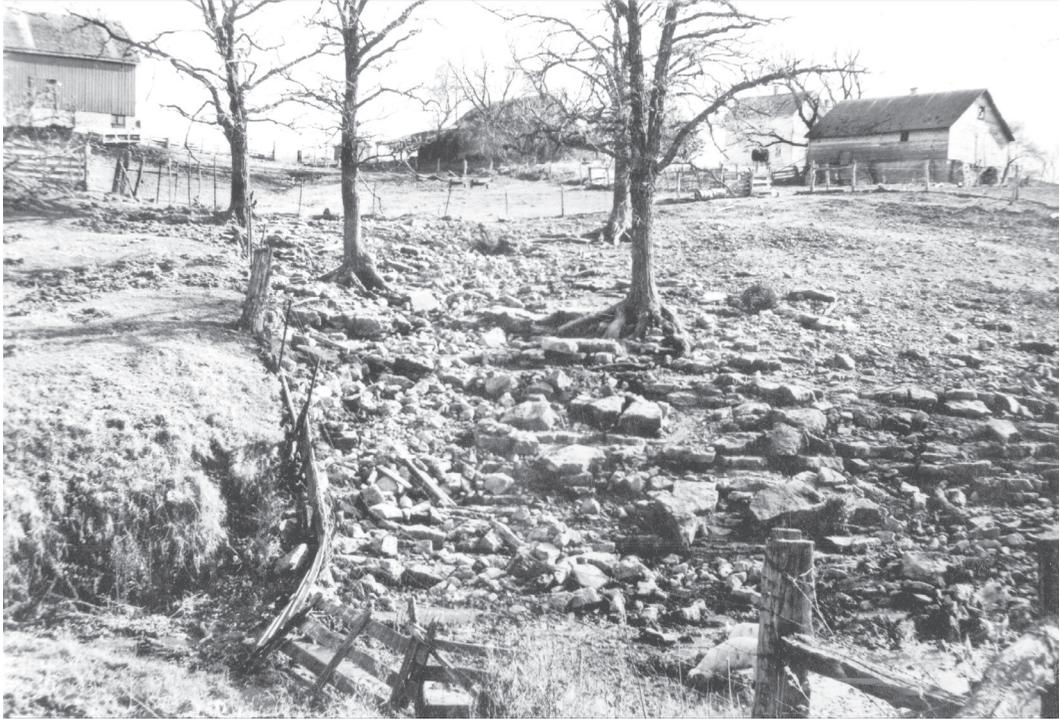
Figure 2.8 An eroded hillside from overgrazing, probably 1950s. (Photo credit: R. Sartz.)

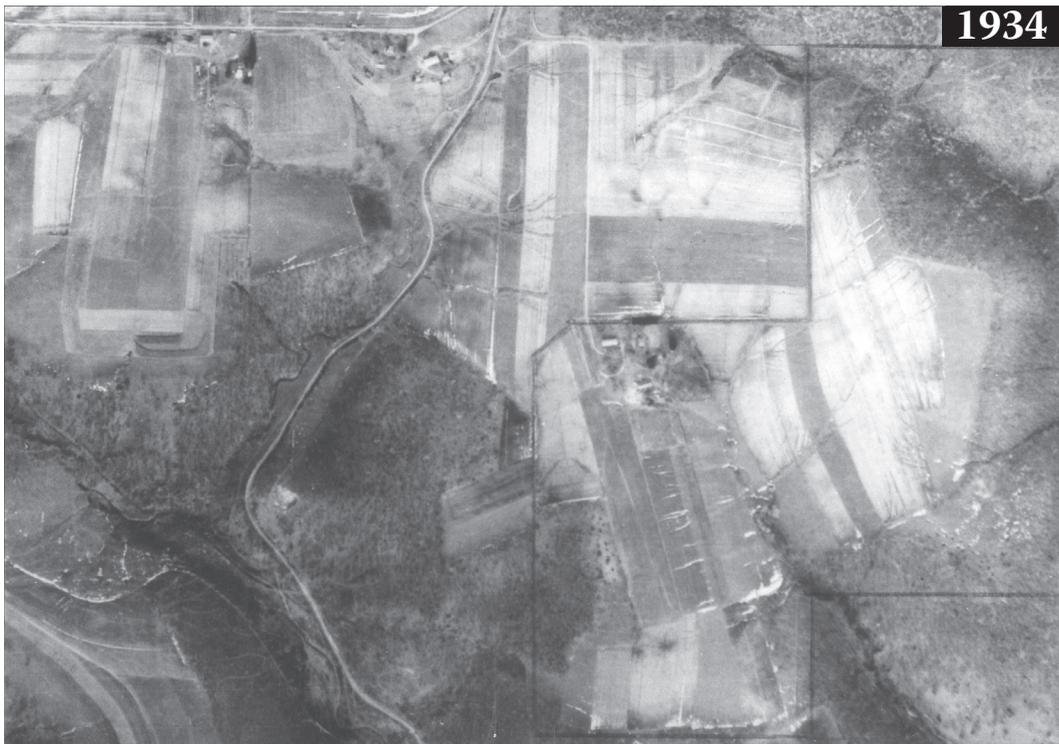
Figure 2.12 Air photos of Coon Creek landscape, 1934 and 1967, just north of Coon Valley (SE1/4,T15N, R5W, Vernon Co.). 1934: Note rectangular fields and gully systems extending into upland cultivated fields. (From Trimble, S. and Lund, S., *US Geol. Surv. Prof. Paper 1234*, 1982.) (Continued)

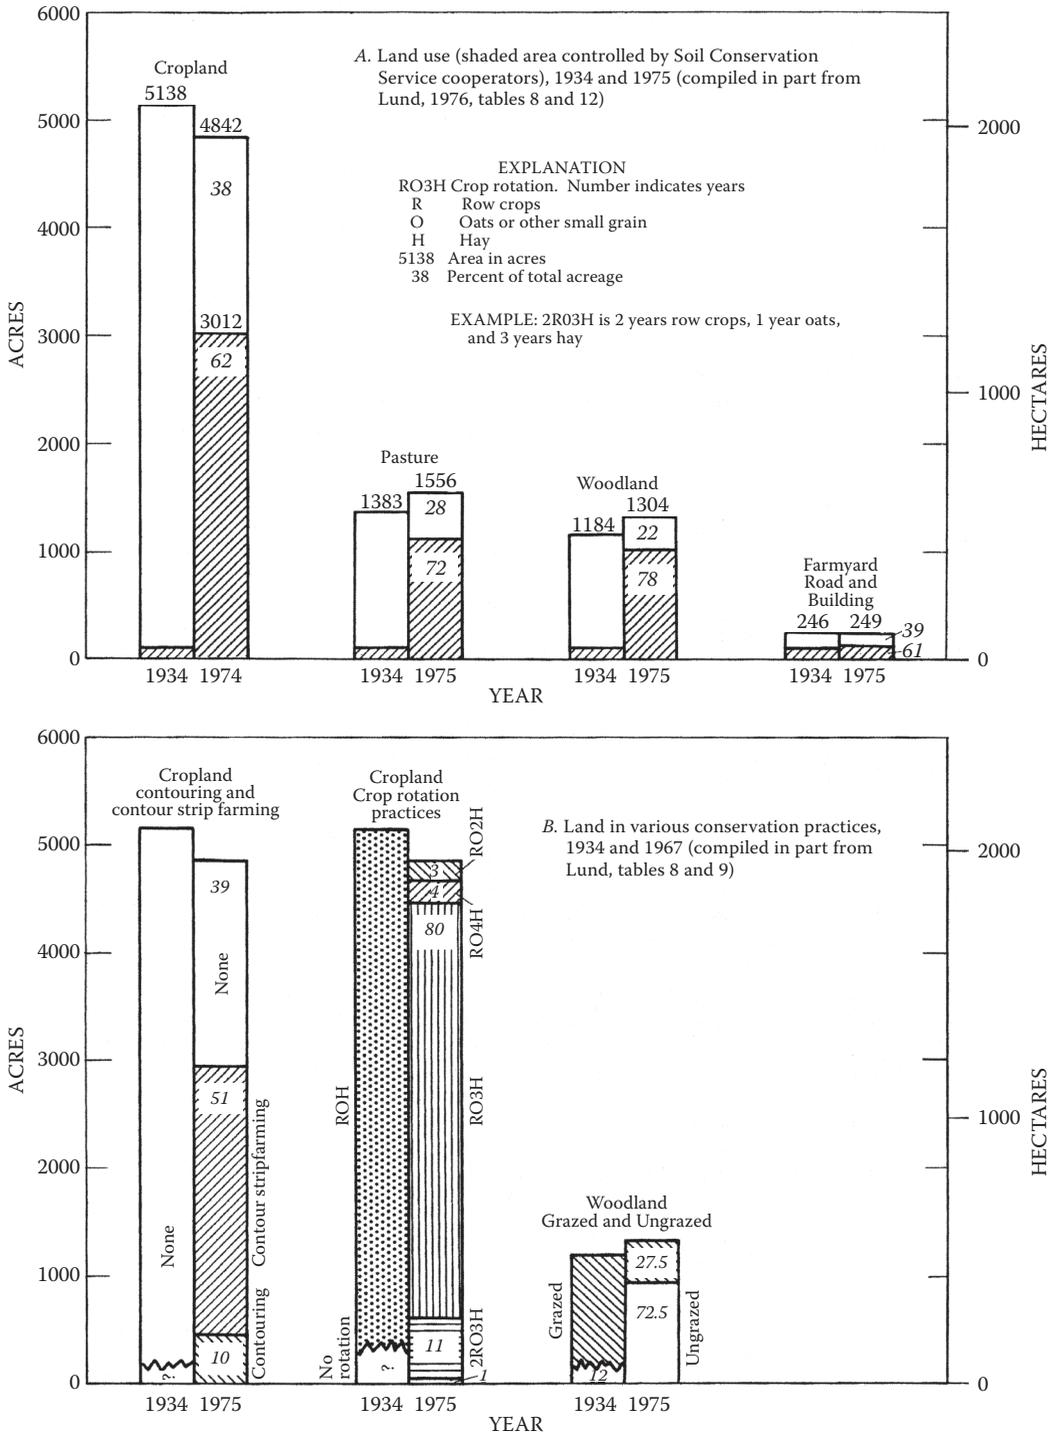
Figure 2.13 Changes of land use and management in 10 sample basins, Coon Creek, WI, 1934 and 1974. (From Trimble, S. and Lund, S., *US Geol. Surv. Prof Paper 1234*, 1982.)

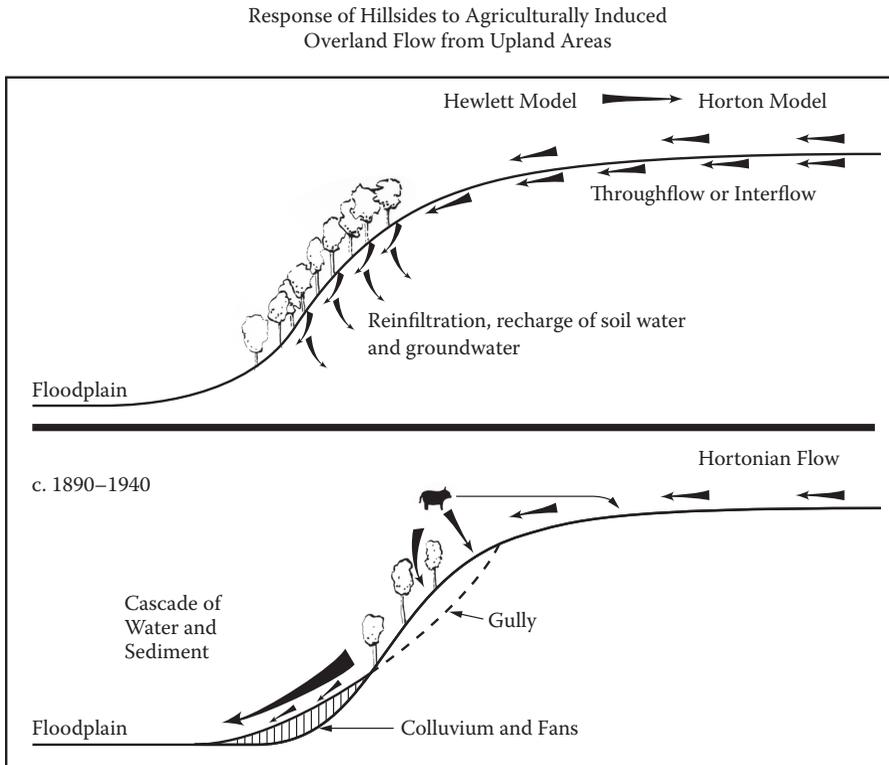
Figure 3.1 Schematic of response of hillsides to agriculturally induced overland flow from upland areas. Top: Early; with increasing crops on the upland and deteriorating soil hydrologic conditions, runoff increasingly becomes surface (Horton Model) rather than subsurface (Hewlett Model), but hillside woodlands are able to infiltrate much of this. Bottom: With increasing overland flow from above and decreased infiltration on grazed hillsides, gullies form and create fans at the toe of the slope.

Figure 3.1 Schematic of response of hillsides to agriculturally induced overland flow from upland areas. Top: Early; with increasing crops on the upland and deteriorating soil hydrologic conditions, runoff increasingly becomes surface (Horton Model) rather than subsurface (Hewlett Model), but hillside woodlands are able to infiltrate much of this. Bottom: With increasing overland flow from above and decreased infiltration on grazed hillsides, gullies form and create fans at the toe of the slope. 56

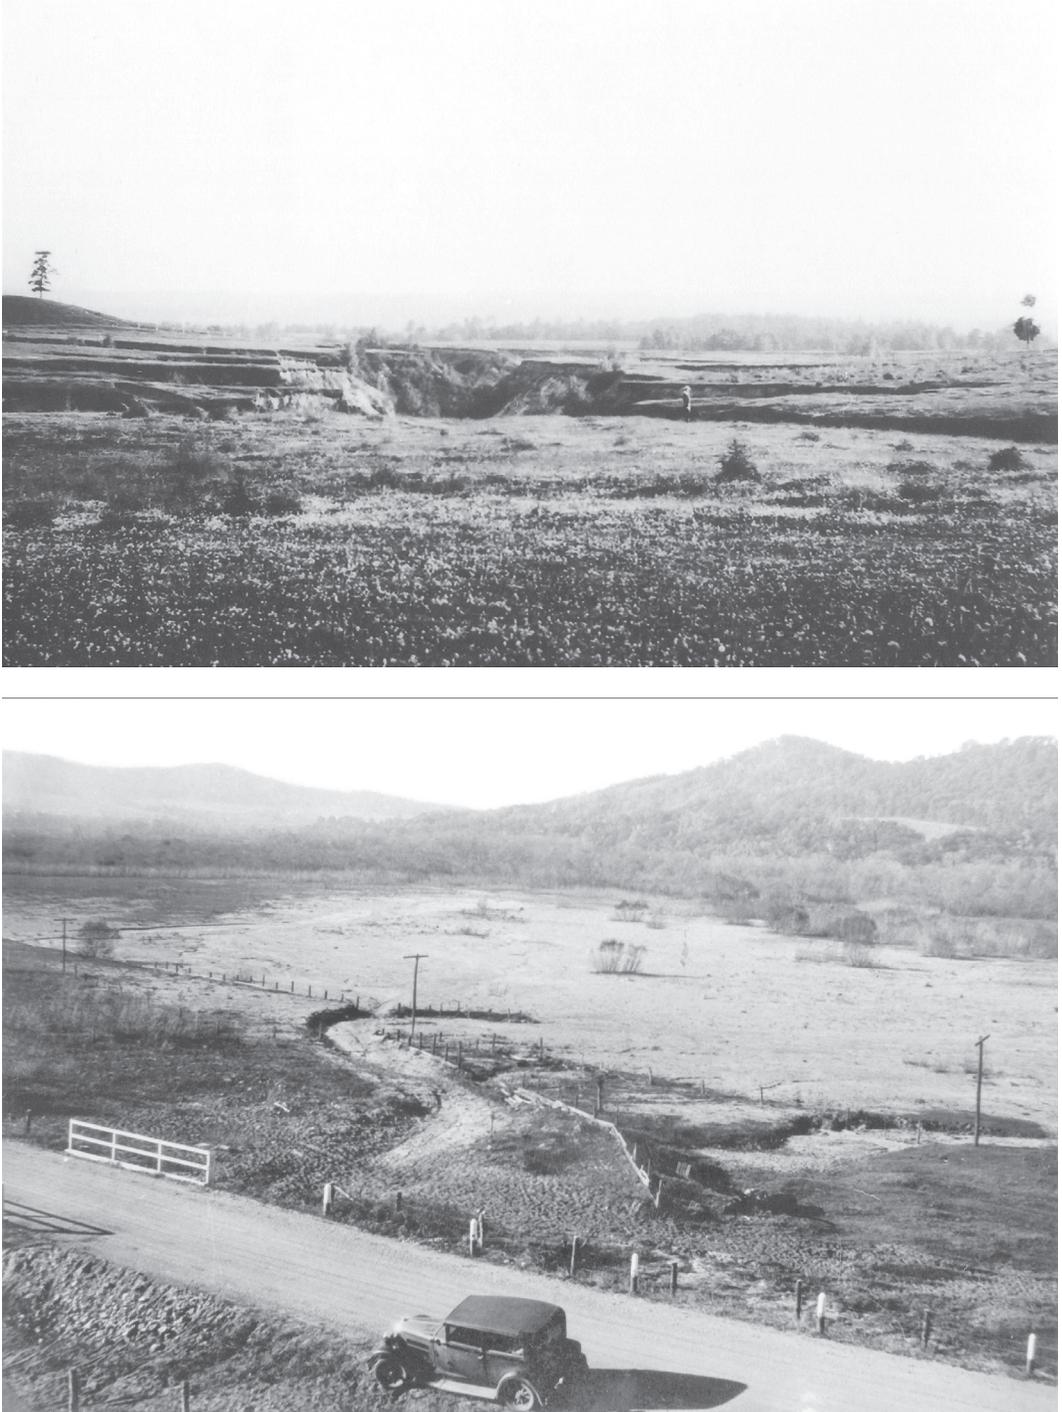
Figure 3.4 Alarming erosion and sedimentation in the Hill Country, 1929–1931. Top: Severe gully-ing in the Black River terrace, 3 mi (5 km) east of North Bend, Jackson Co., WI, June 15, 1929. See also book cover. Bottom: a 40-acre (16 ha) fan, deposited mainly 1923–1929, covers formerly good hay land on the Buffalo River floodplain, 10/24/31. (Photos credit: C.G. Bates.)

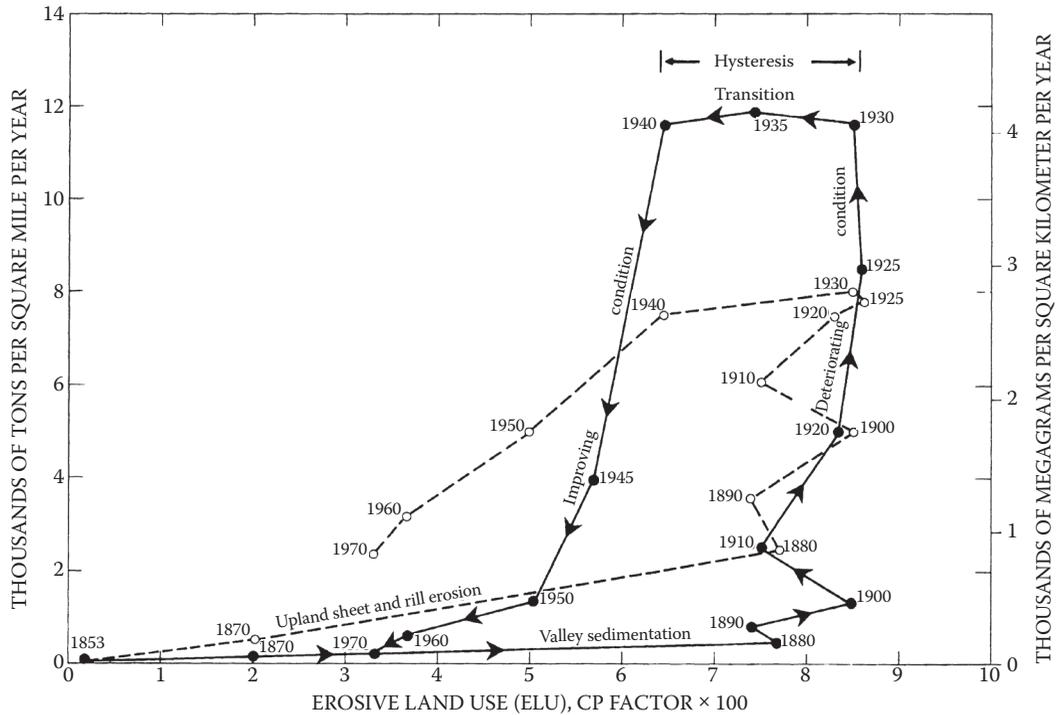
Figure 3.7 Nonlinear and hysteretic relationship of erosion and sedimentation to erosive land use, 1853–1975, Coon Creek. Sedimentation rates were measured but erosion was modeled with the Universal Soil Loss Equation. The lags are largely functions of (a) soil condition and (b) connectivity between uplands and bottoms by rills and gullies. See text for more explanation. (From Trimble, S. and Lund, S., *US Geol. Surv. Prof. Paper 1234*, 1982.)

- Figure 3.7** Nonlinear and hysteretic relationship of erosion and sedimentation to erosive land use, 1853–1975, Coon Creek. Sedimentation rates were measured but erosion was modeled with the Universal Soil Loss Equation. The lags are largely functions of (a) Soil condition and (b) connectivity between uplands and bottoms by rills and gullies. See text for more explanation. (From Trimble, S. and Lund, S., *US Geol. Surv., Prof. Paper 1234*, 1982.) 66

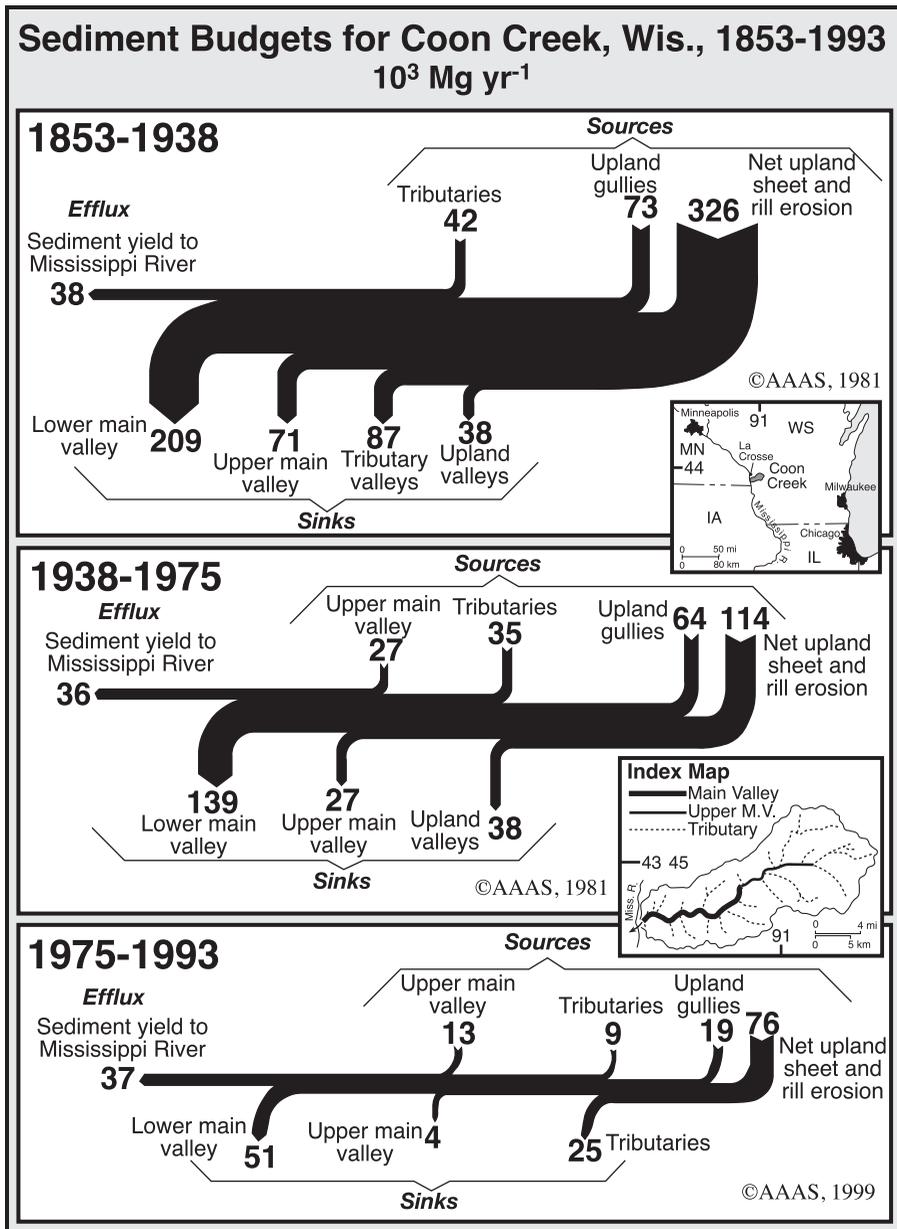
Figure 3.8 Sediment budgets for Coon Creek, 1853–1993, showing the complexity of sources, sinks, fluxes, and efflux over time. Numbers are annual averages for the periods in tonnes/yr (1 tonne = 1.1 short tons). All values are direct measurements except net upland sheet and rill erosion, which is a tare: the sum of all sinks and the efflux minus the measured sources. The lower main valley and tributaries are sediment sinks, whereas the upper main valley has been a sediment source. Note that sediment yield to the Mississippi River has held relatively constant over historical time. (From Trimble, S., *Science* 285, 1244–46, 1999. With permission.)

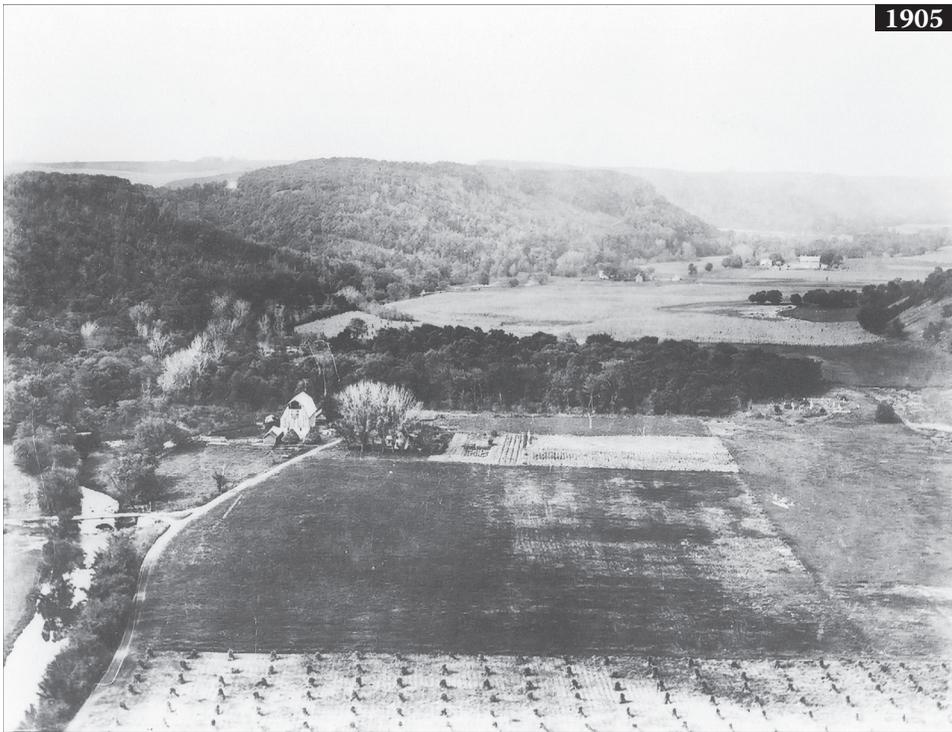
Figure 3.12 Evolution of tributary channels as explained in the text and in Figures 3.10 and 3.11. North Branch, Whitewater River, MN, 1 mi (1.6 km) west of Elba, MN, looking upstream (west) (NE1/4, Sec9, T107NR10W, Winona Co.). For reference, note barn, bridge, and road intersection. 1905, Note narrow, apparently deep stream lined with trees and dense riparian vegetation. (Photo credit: 1905 and 1940 photos by Soil Conservation Service [SCS].) (Continued)

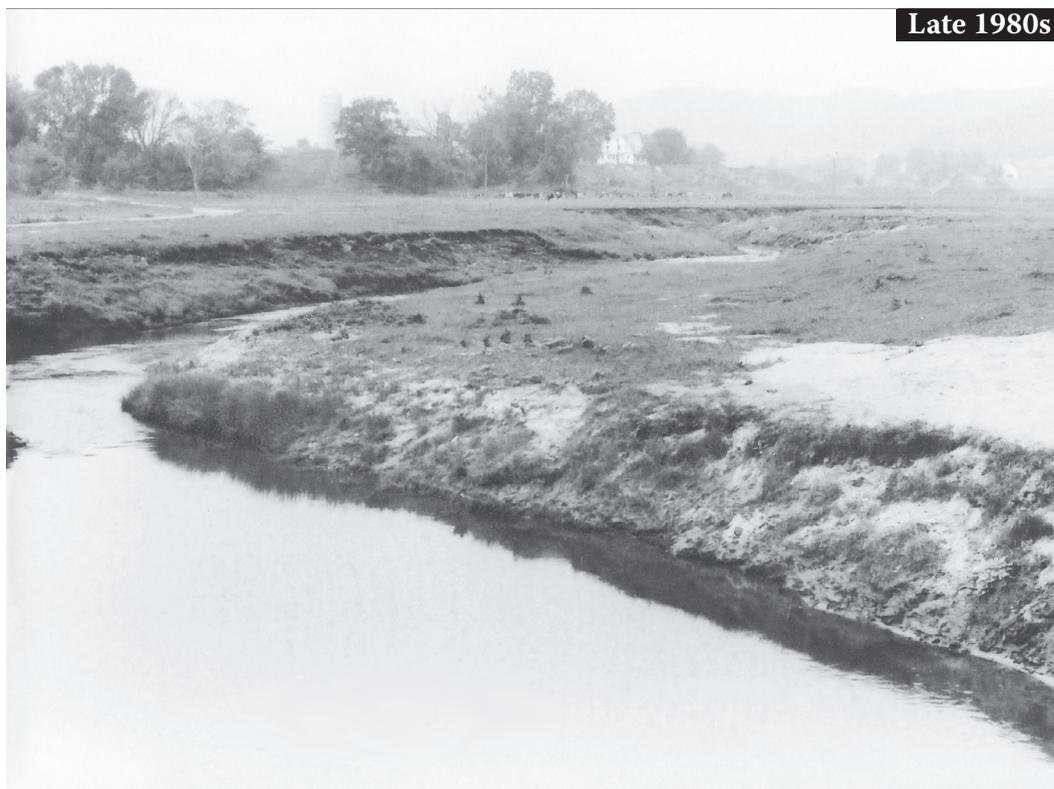
Figure 3.14 (Continued) Downstream end of the Upper Main Valley of Coon Creek, as defined by the process of a stream eroding a high bank and depositing a lower bank on the other side of the stream adjusted to a lower flood regime. Late 1980s. Note that the stream has cut away the bank to the left foreground and is depositing a slightly lower bank in the right foreground. The same pattern exists for two more meander loops in the distance (looking downstream from bridge over Coon Creek, NW1/4, Sec 24,T14N, R6W).

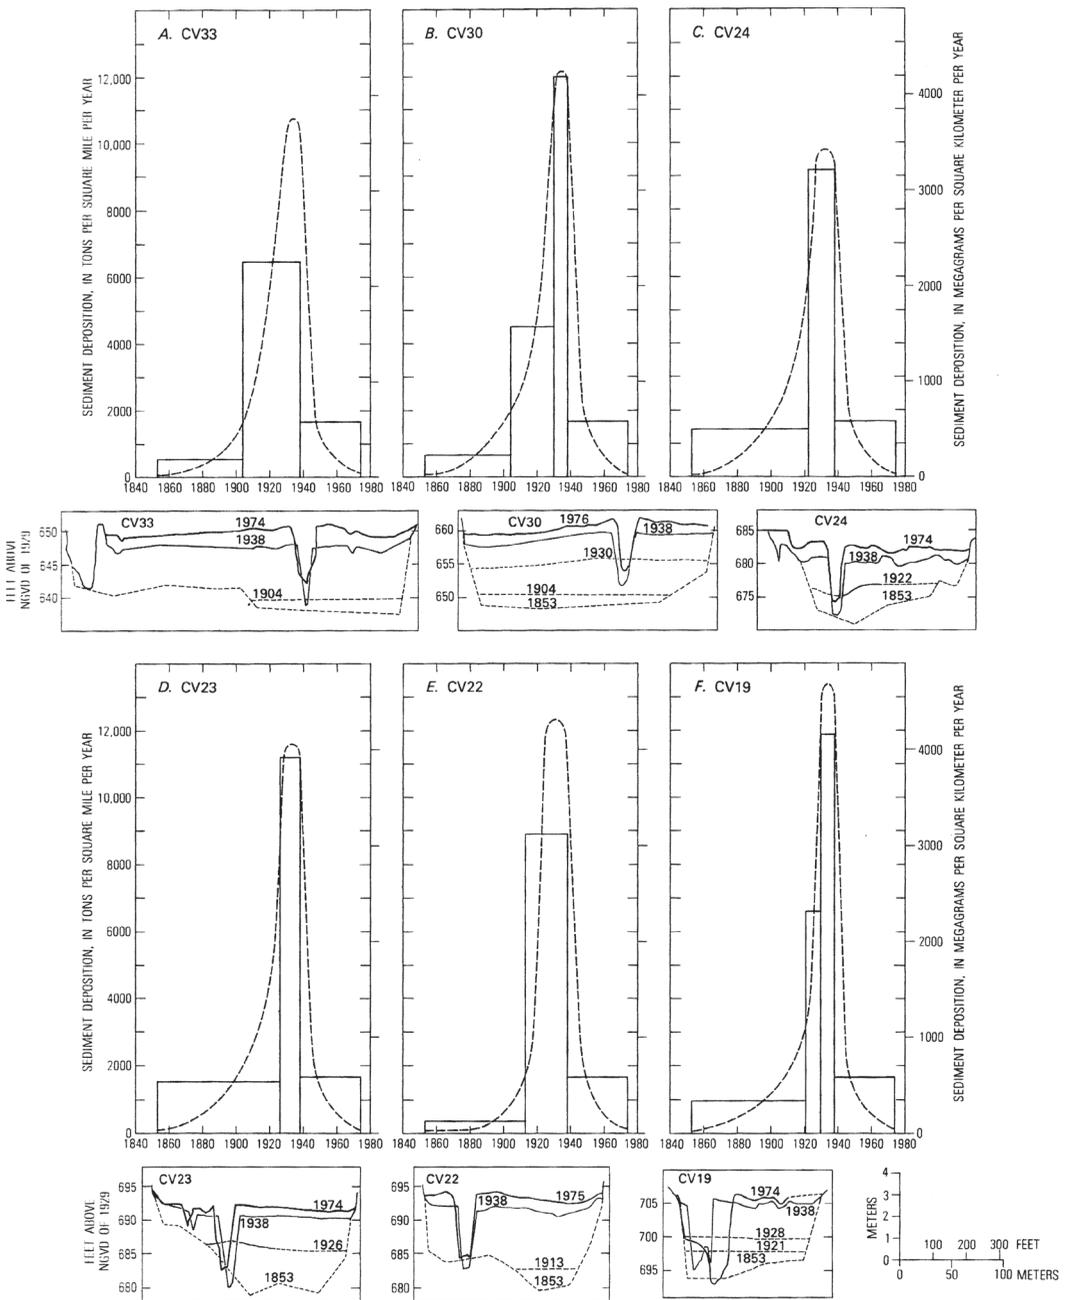
Figure 3.15 Deposition rates at selected Lower Main Valley sites in Coon Creek, 1853–1977. These are derived from cross-sectional reconstructions of deposition rates based on surveys, excavations of soils, bridges, roadways, and other dating methods. (From Trimble, S. and Lund, S., *US Geol. Surv. Prof. Paper 1234*, 1982).

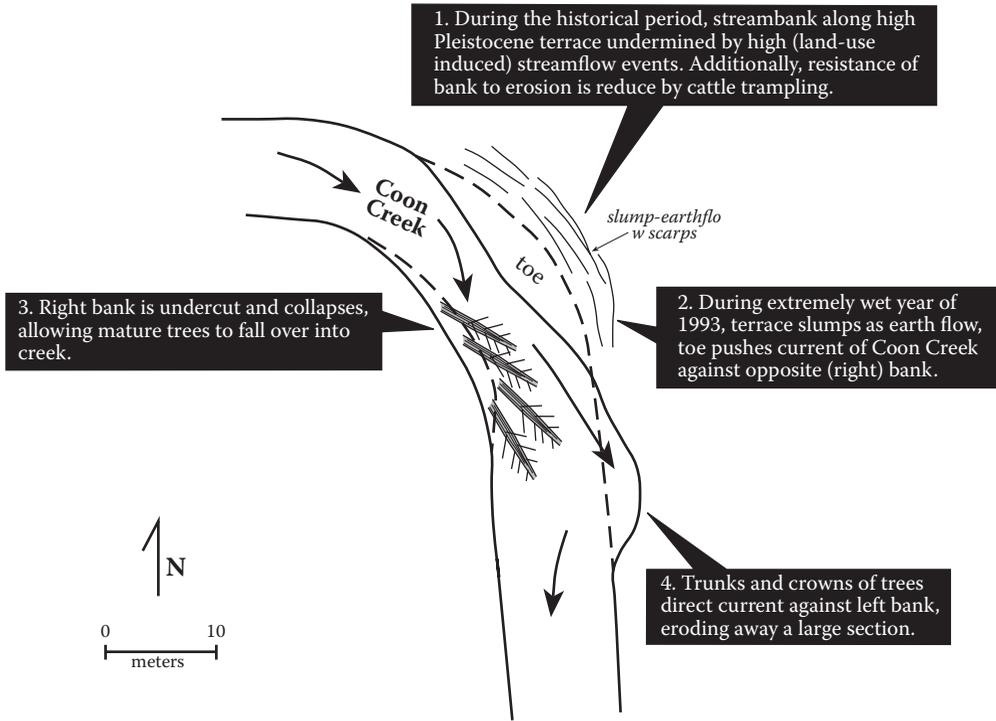
Figure 3.17 Destabilization of stream reach by collapse of undercut high terrace, showing natural and human factors. This reach may be observed by looking upstream (south) from WI State Highway 162 bridge over Coon Creek (see Fig. 8.14).

Figure 3.17 Destabilization of stream reach by collapse of undercut high terrace, showing natural and human factors. This reach may be observed by looking upstream (south) from WI. State Highway 162 bridge over Coon Creek (see Fig. 8.14). 84

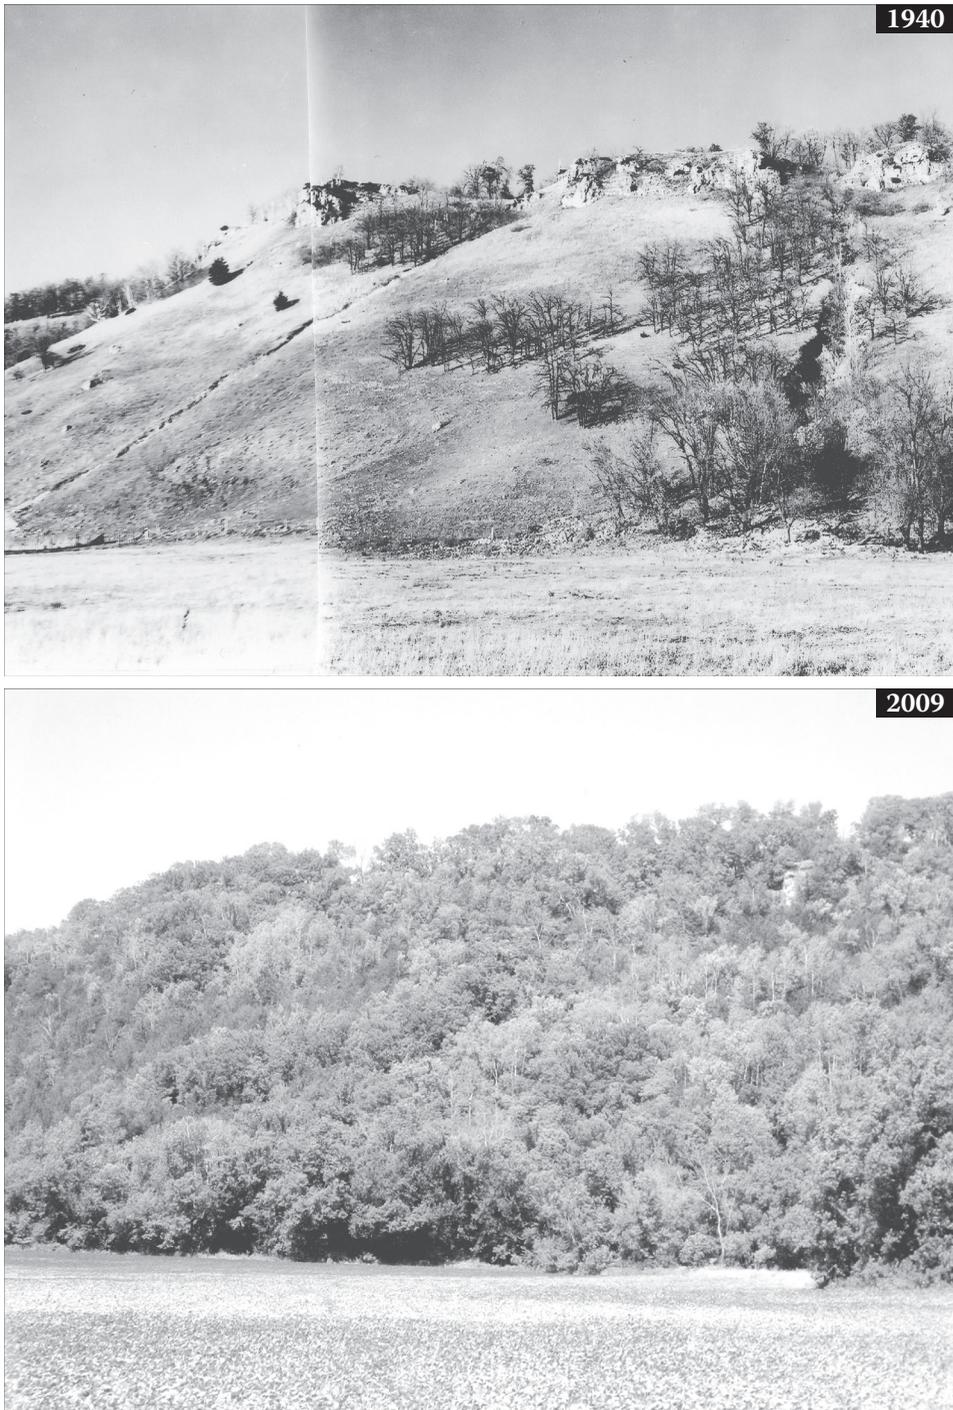
Figure 4.1 Stabilization of hillside and gullies, North Fork Whitewater River, looking north just east of Fairwater, MN (SE1/4, Sec 5, T107N, R10W, pan of two photos made 10/23/40). Top: 1940, note treeless “goat prairie” and two hillside gullies with fans at base of slope. Bottom: July 2009, note the transformation from “goat prairie” to mostly deciduous forest. Gullies and fans are relatively inactive. Compare to Chapter 5, Figure 5.1 of the same slopes. (See also Trimble, 2009a, p. 18.)

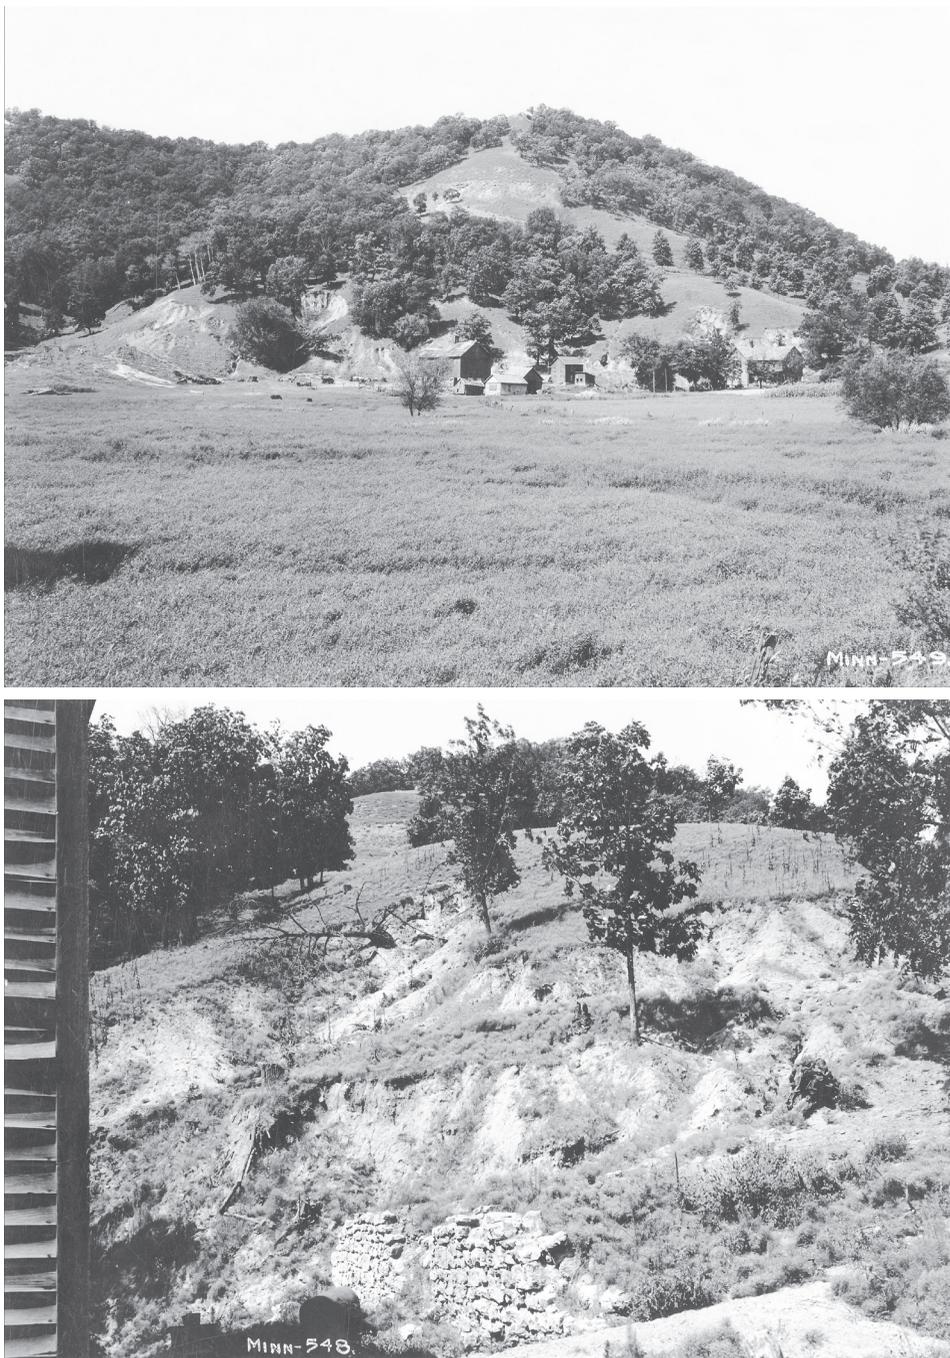
Figure 4.3 The Appleby farm, Whitewater Valley looking north (NW1/4, Sec 10, T108N, R10W, Winona County, MN). Top: The farm seen across the floodplain, grown too wet for grazing. Thus, Appleby was forced to turn his animals loose on the hillside behind the house, and gullies are visible. Bottom: Close-up of gullied hillside behind house with partially buried stone wall visible. Corner of house visible to left. Both photos 8/27/37. A present remake of the top photo would show the lake formed in the foreground as the main channel of the Whitewater River aggraded to a level higher than the distal floodplain here (see Chapter 7).

Figure 4.3 The Appleby farm, Whitewater Valley looking north (NW1/4, Sec 10, T108N, R10W, Winona County, MN). Top: The farm seen across the floodplain, grown too wet for grazing. Thus, Appleby was forced to turn his animals loose on the hillside behind the house, and gullies are visible. Bottom: Close-up of gullied hillside behind house with partially buried stone wall visible. Corner of house visible to left. Both photos 8/27/37. A present remake of the top photo would show the lake formed in the foreground as the main channel of the Whitewater River aggraded to a level higher than the distal floodplain here (see Chapter 7). 89

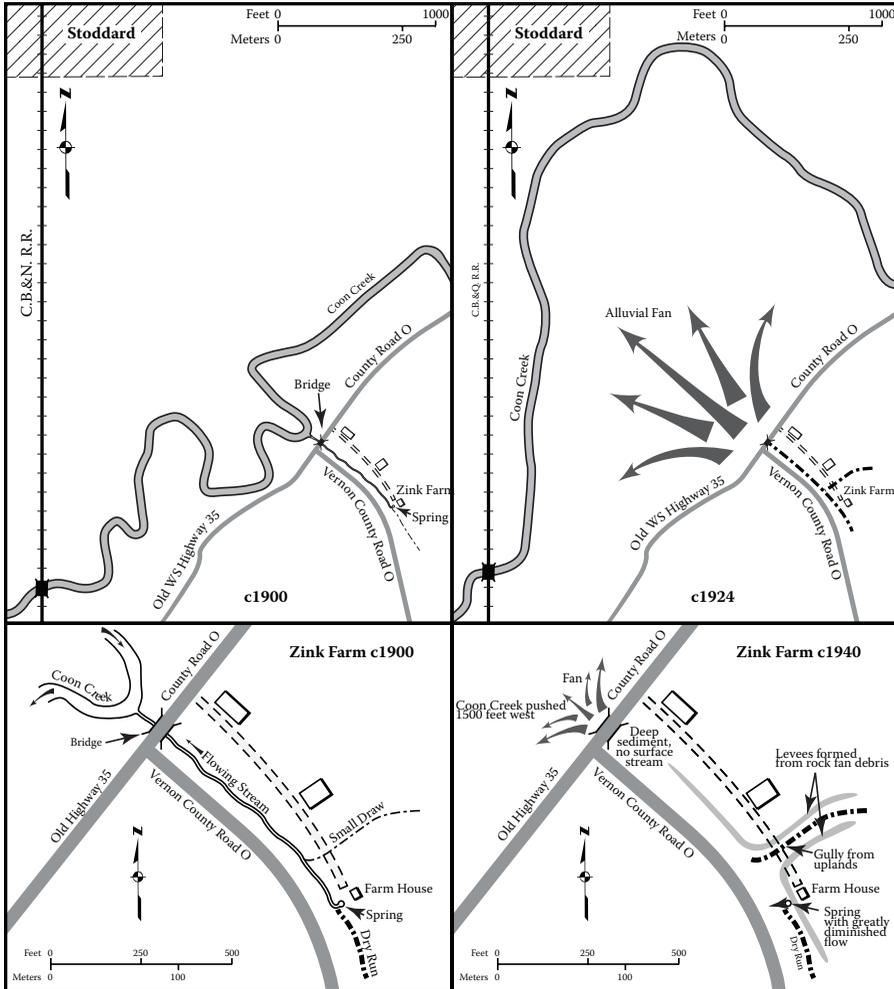
Figure 4.4 Changes at the Zink farm about 1 mi (1.6 km) southeast of Stoddard, WI, c. 1900–1940 (NE1/4, Sec33, T14N, R7W). In 1900, Coon Creek still ran on the east side of the valley close to the Zink farmstead. By 1924, the small tributary from the southeast had formed an alluvial fan that has pushed the creek across to the west side of the valley. This process clearly demonstrates the rapid onset of disastrous erosion in the early 20th century.

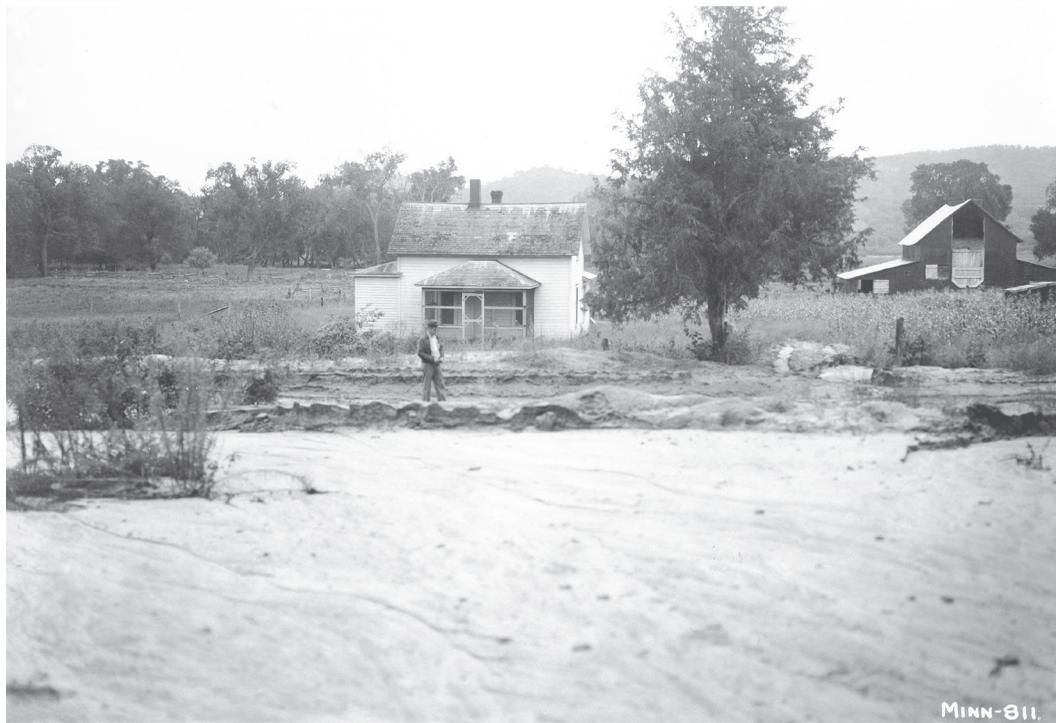
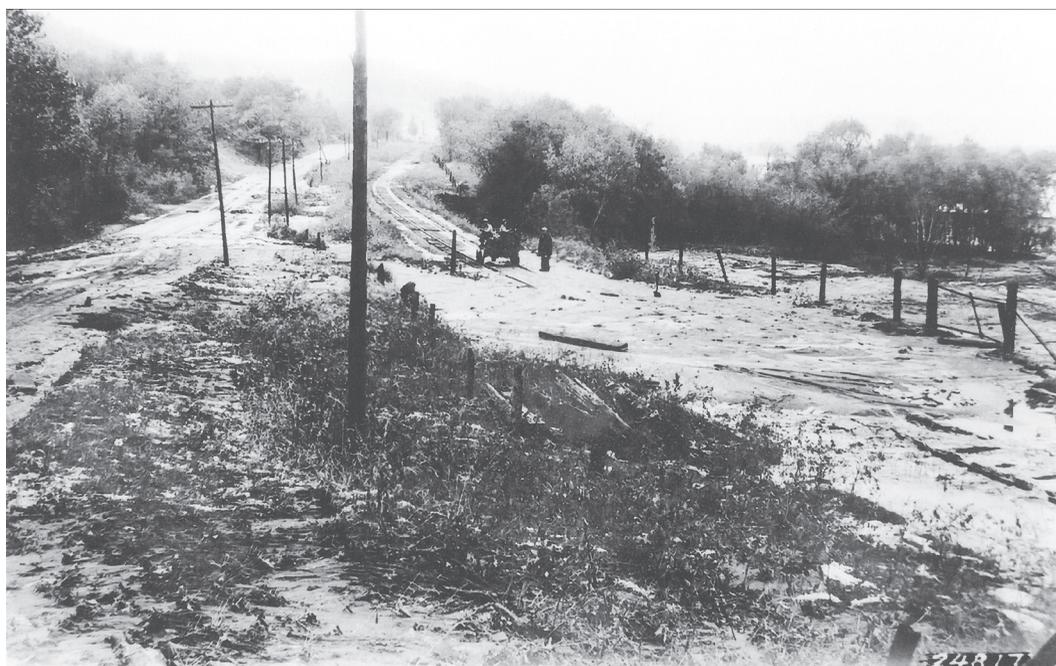
Figure 4.7 Examples of gully fans covering roads and railroads. Top: Sand fan over MN highway 74, 2 mi (3 km) west of Weaver, 9/7/38, looking south. (Photo credit: Vince McKelvey). Farm in background was already abandoned. Bottom: sand fan over railroad, location unknown. (Photo credit: C.G.Bates, 8/2/30.)

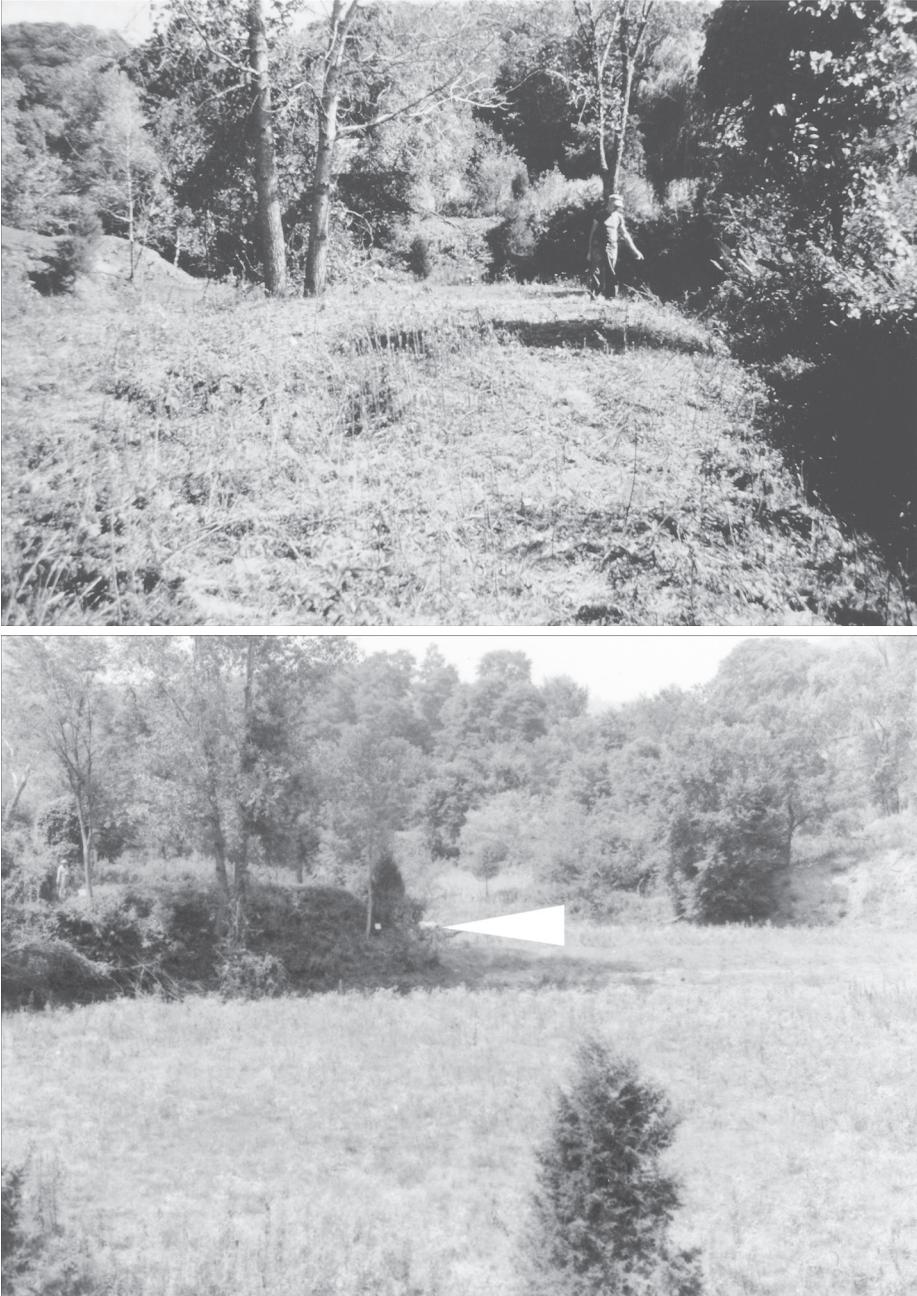
Figure 4.13 Top: Elmer Miller in 1977 points to a portion of the ditch his grandfather dug in 1905 to drain the bottom of the channel. Subsequent trenching bypassed this reach of the ditch and cut around the left side (to the viewer here looking upstream) leaving this part isolated and elevated. Bottom, 1977: Looking downstream at the terrace floor remnant on which Miller stands in top photo. Dr. Stafford Happ stands in the gully remnant. For some reason, perhaps a blocked channel, the gully cut around to the right and bypassed this site. The two white flags on slope to right (arrow) mark the buried dark soil of the original (pre-trench) valley bottom, covered with about 6 ft (2 m) of historical sediment. The gully floor in the foreground to the right is now covered with about 6 ft (2 m) of alluviation adjusted to the aggraded floodplain of Coon Creek 1000 ft (300 m) downstream.
