**HISTORICAL AGRICULTURE
AND SOIL EROSION IN THE
UPPER MISSISSIPPI
VALLEY
HILL COUNTRY**

STANLEY W. TRIMBLE

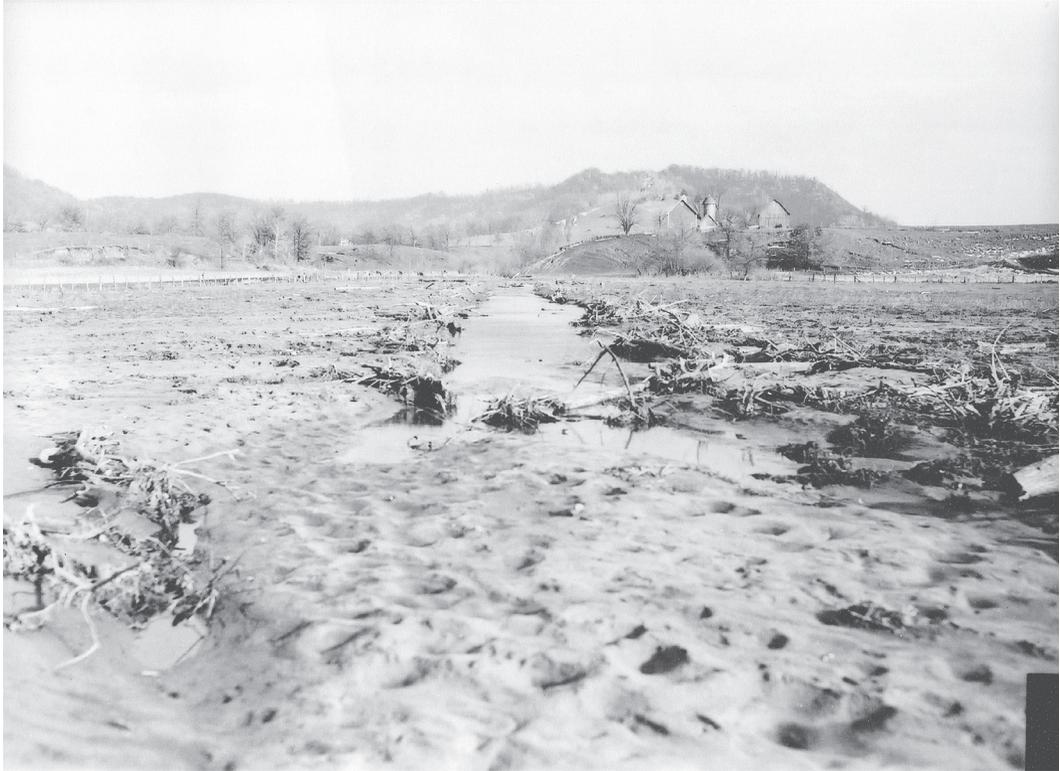
Figure 4.15 Alluvial fan from Proksch Trench on Coon Creek floodplain looking northeast up the channel. (Photo credit: S.C. Happ, 11/11/38 (NW1/4, Sec27, T14N, R7W, Vernon Co.) The extremely straight channel appears to have been dug and is completely occluded (filled up) in the foreground. Note sandy wash on floodplain and obviously wet conditions. However, this huge influx of sand has created an elevated fan out across the floodplain quite visible on the most recent USGS *Stoddard* sheet (1:24,000, 1983).

completely occluded (filled up) in the foreground. Note sandy wash on floodplain and obviously wet conditions. However, this huge influx of sand has created an elevated fan out across the floodplain quite visible on the most recent USGS *Stoddard* sheet (1:24,000, 1983). 104

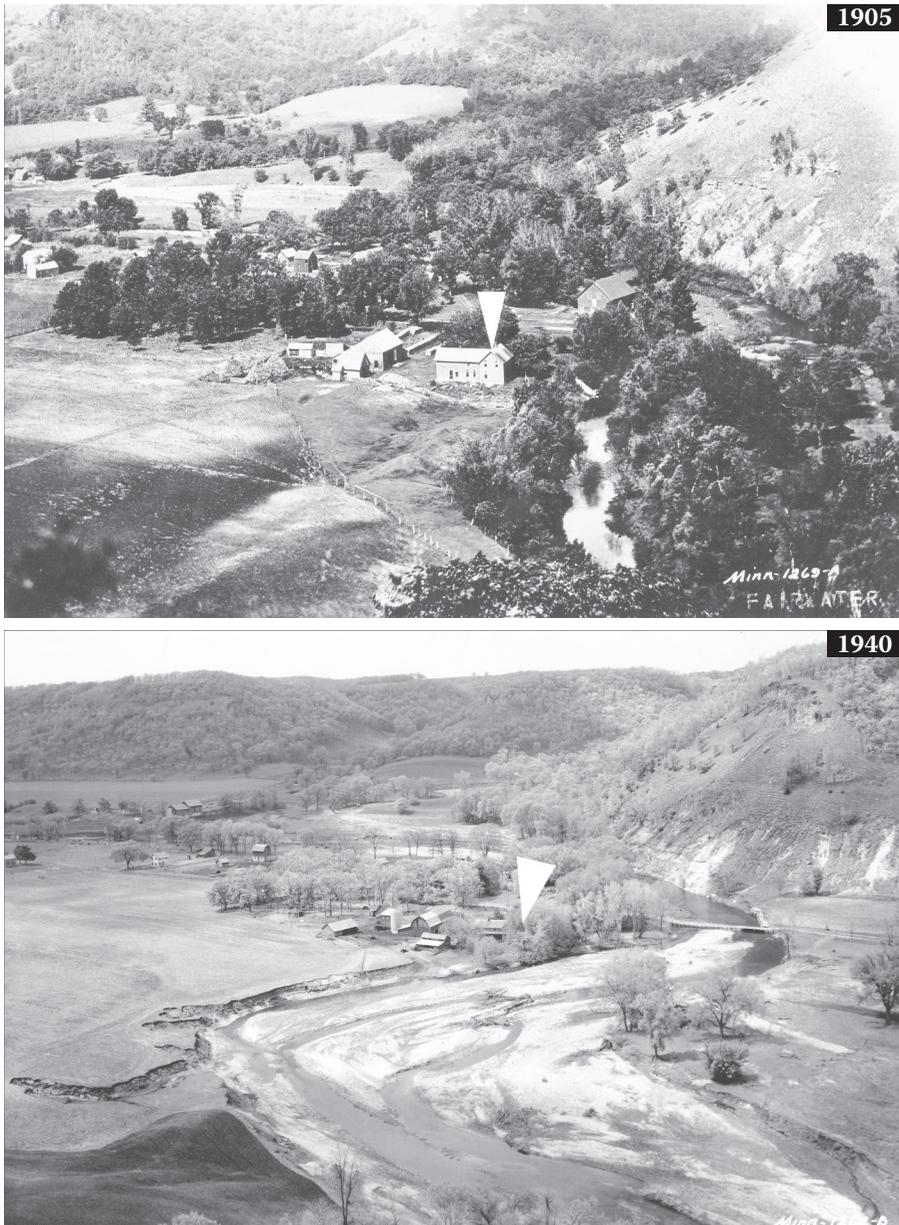
Figure 5.4 Fairwater, destruction of the high Pleistocene terrace, looking north/northwest (upstream) from hill on southeast side of the village. c. 1905: stream is narrow and tree-lined. House (arrow) is the same as marked in 5.3. Large, dark building just upstream from house is the mill. 1940: same view but taken farther back. Using the house as a marker, it will be seen that the stream had eroded laterally perhaps 150–200 ft to the left (west) and a comparable distance toward the viewer (south, see Figure 5.3). Not only is the high terrace eroding from stream action but is also eroding from agricultural runoff as evidenced by the lateral gullies. As a result of flooding and coarse sediment, the stream is now braided. The visible bridge is a replacement for a bridge similar to the one seen in Figure 5.5. A comparison of this area c. 1940 (Brown and Nygard, 1940) with the 1972 USGS topographic sheet *Elba* (1:24,000) suggests that about 4 acres (1.6 ha) of terrace were eroded away in those 32 years. Conservatively, assuming an average net removal depth of 10 ft (3 m), about 40 acre-feet (49,400 m³) of material were lost here with much being moved to the main valley of the Whitewater River. Note that goat prairie in background is now covered with cedar (same as seen in Figure 5.1). (Continued)

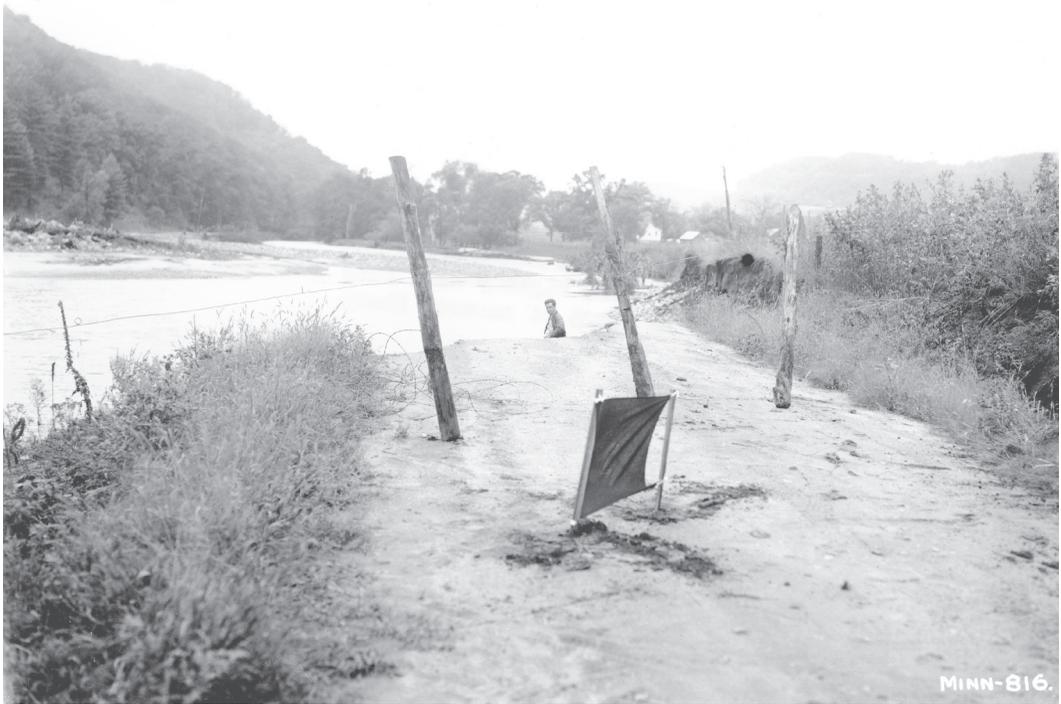
Figure 5.6 Fairwater, road from Elba to Fairwater about 1 mi east of Fairwater, 9/38, looking west. Several hundred feet of roadway eroded away.

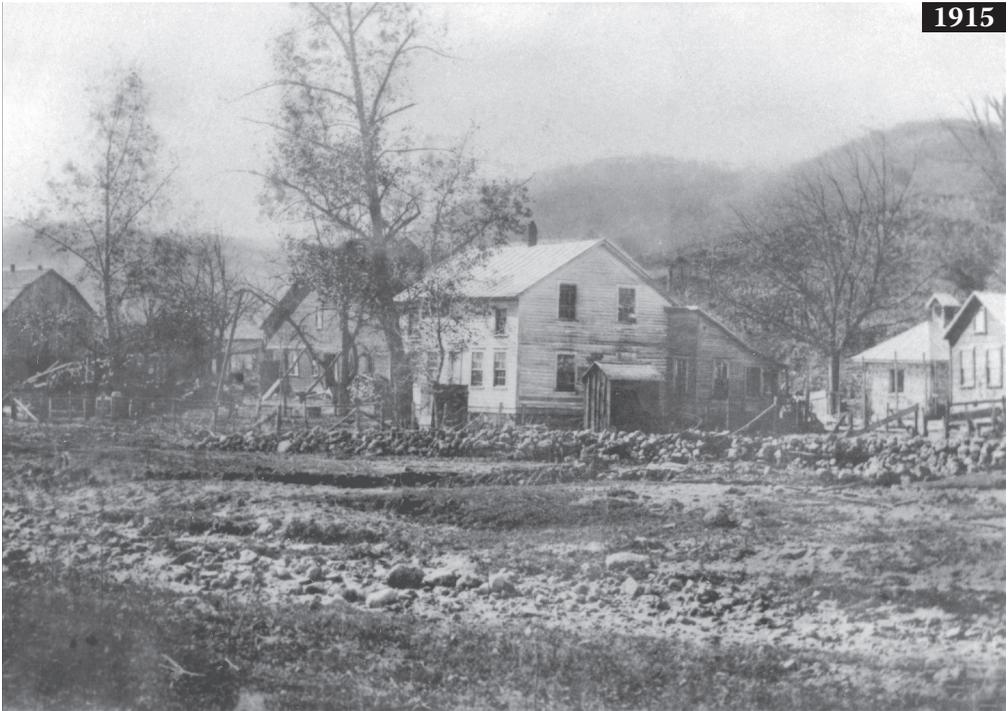
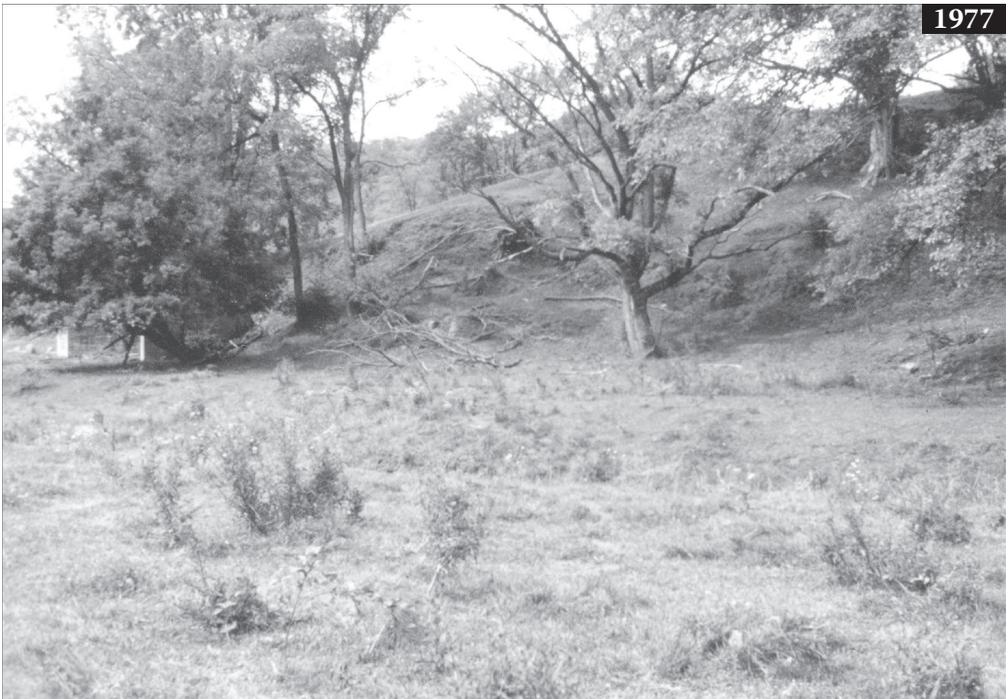
Figure 5.9 Hass house, Deadman's Creek (NE 1/4 Sec 19, T10N, R6W, Vernon County, WI). 1915: Creek in the foreground flowing to the left (east). House sits behind flood dike made of boulders brought down by creek. 1977: stable, grassy floodplain, stream out of view in foreground. House foundation is buried in floodplain in middle ground.

- Figure 5.9** Hass house, Deadman’s Creek (NE 1/4 Sec 19, T10N, R6W, Vernon County, WI). 1915: Creek in the foreground flowing to the left (east). House sits behind flood dike made of boulders brought down by creek. 1977: stable, grassy floodplain, stream out of view in foreground. House foundation is buried in floodplain in middle ground..... 123

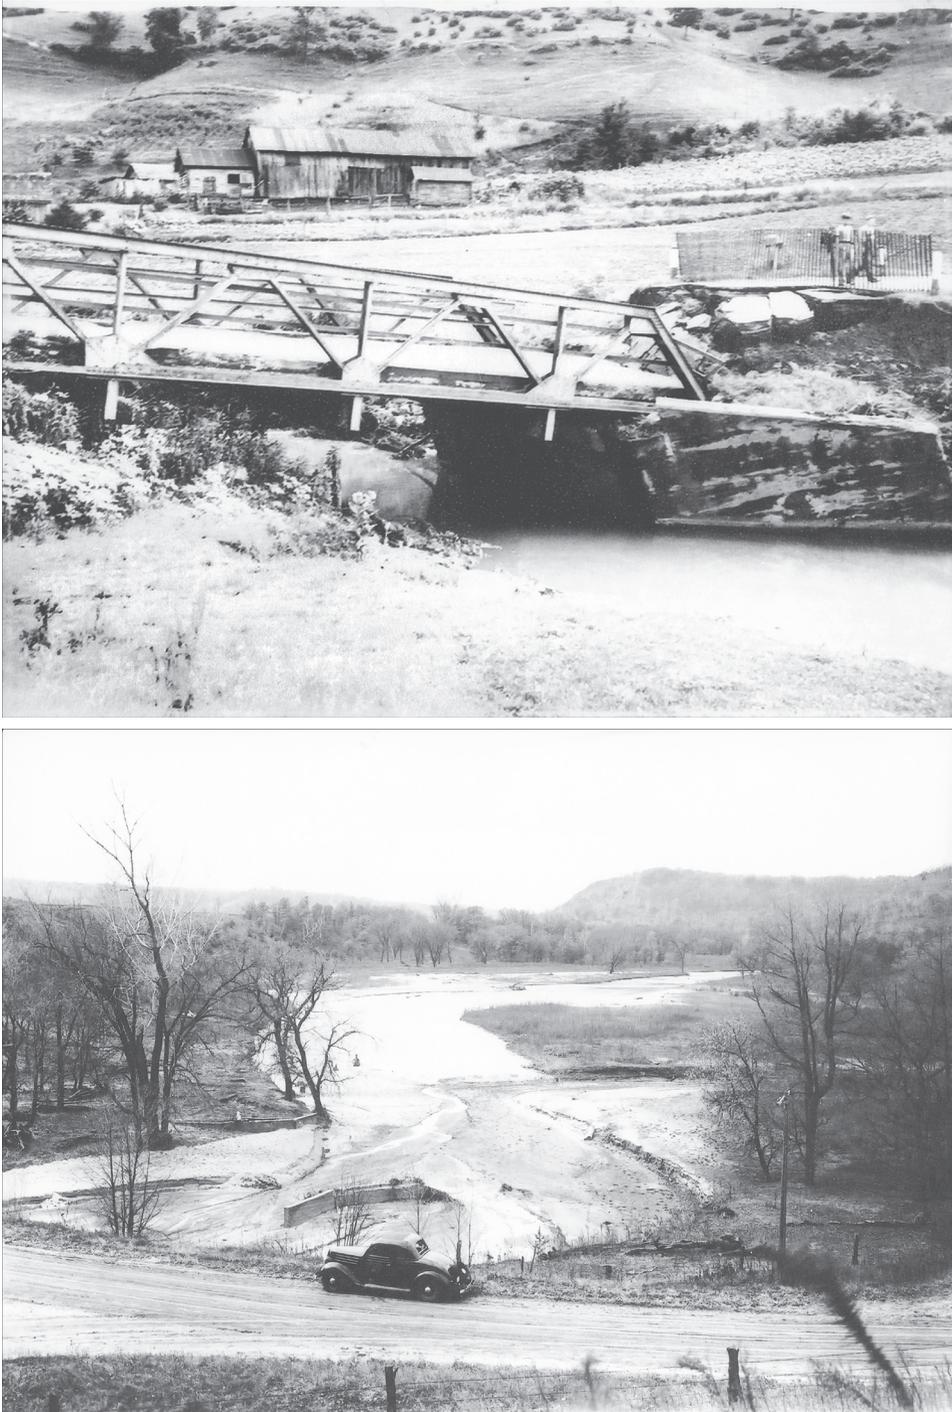
Figure 5.10 Bridges over tributaries destroyed by flooding and sediment. Top: Undermined bridge in the Coon Creek basin, exact location unknown, 1938 (from McKelvey, V.E. 1939. Stream and valley sedimentation in the Coon Creek drainage basin, Wisconsin: M.A. thesis, University of Wisconsin-Madison). Bottom: Abutment of destroyed bridge over Trout Brook near Dumfries, MN. Zumbro River Valley, 1939 (Sec 10, T110N, R11W, Wabasha County) (SCS Photos).

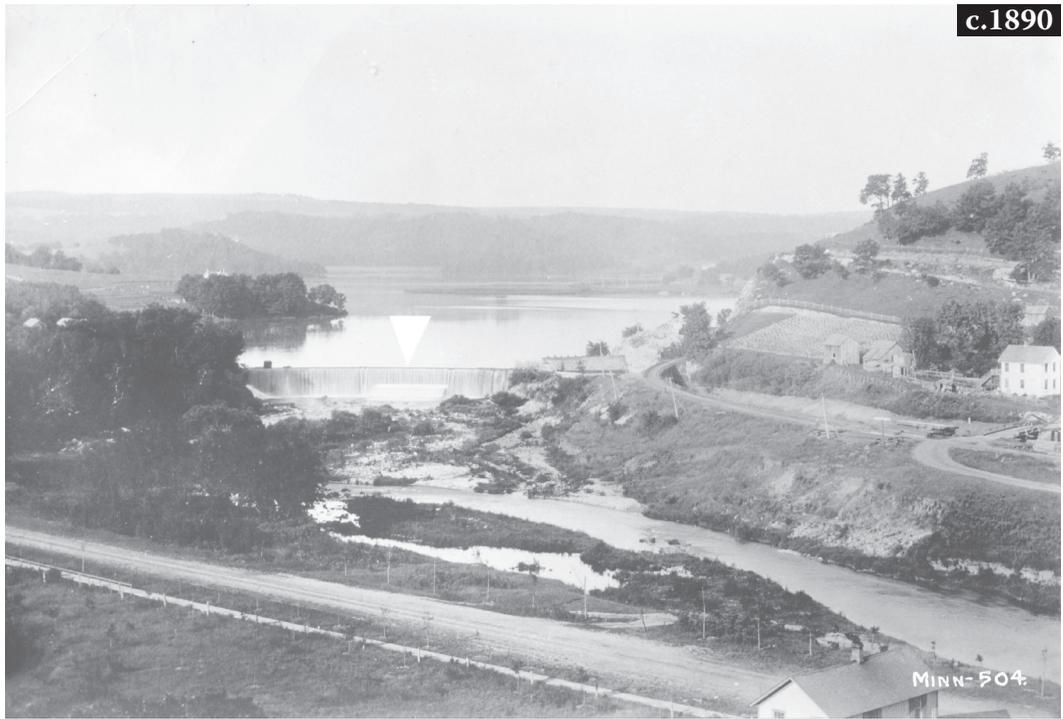
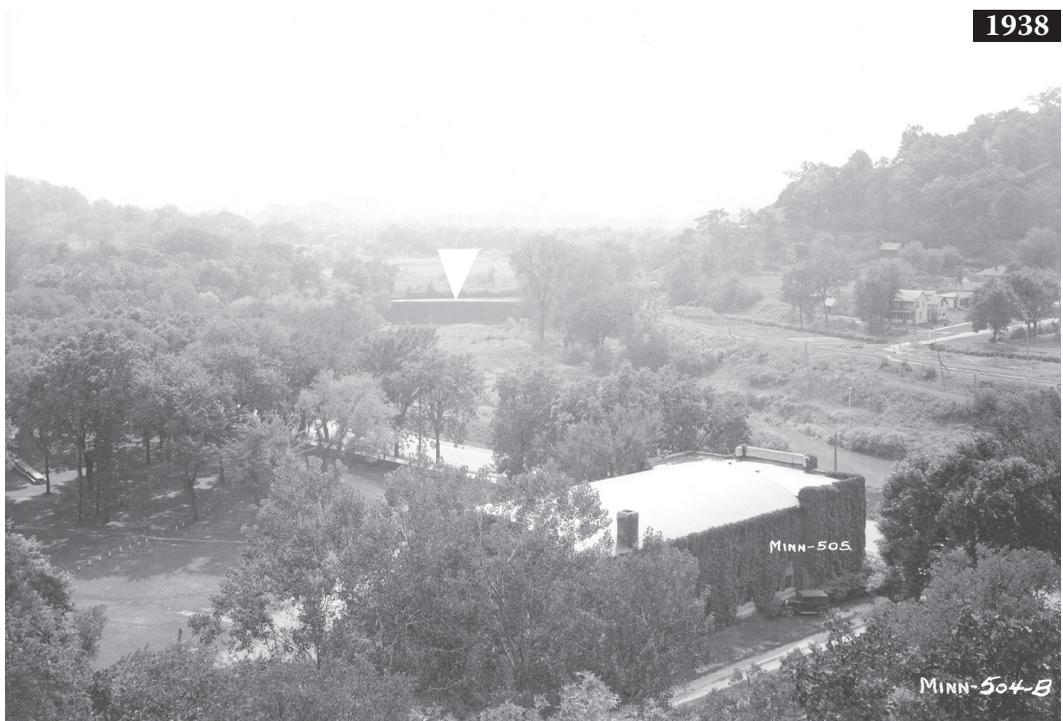
Figure 5.13 Lanesboro Lake, Lanesboro, MN, on the upper Root River. C. 1890: large expanse of water. 1938: completely filled with sediment. Arrow marks top of dam in both photos. (Photo credit Soil Conservation Service [SCS].)

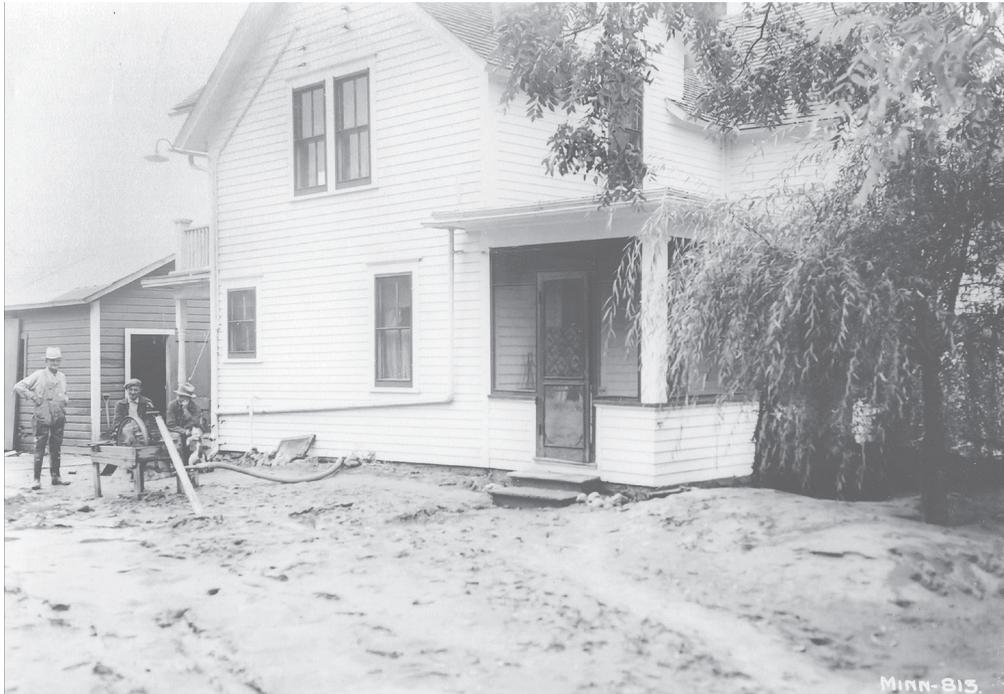
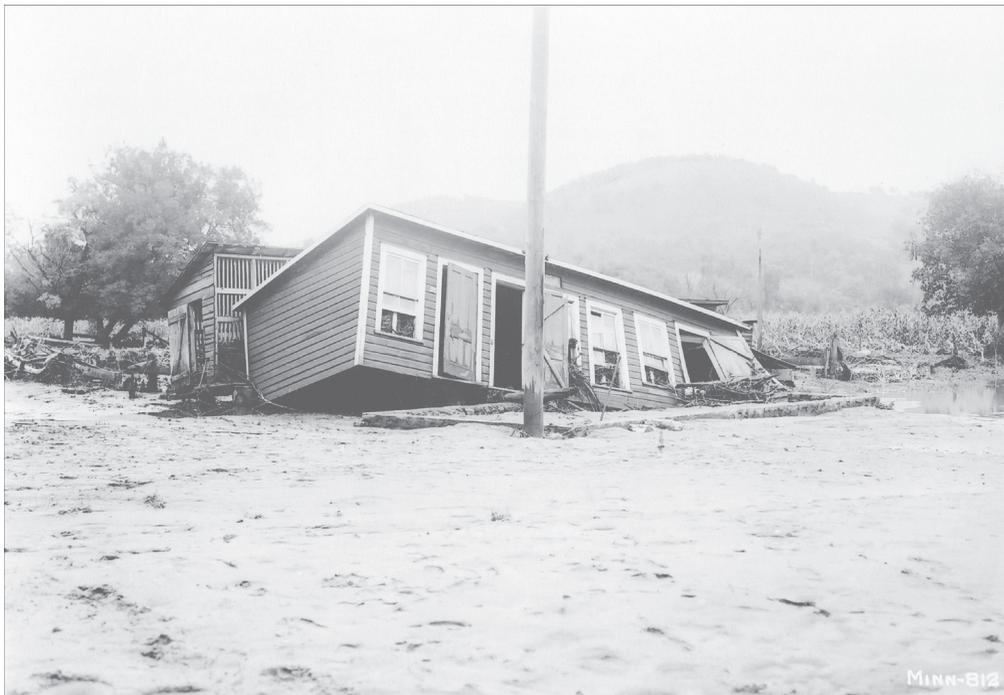
Figure 6.1 Nick Siebenaler's house just upstream from Elba, MN, on a terrace above the Whitewater River. Flood 9/8/38. Top: Floodwater was up halfway on screen door. The men are pumping out the basement. Bottom: Siebenaler's chicken house was moved off the foundation by the flood. Note sediment deposits in foreground. (Photo credit Soil Conservation Service [SCS].)

- Figure 6.1** Nick Siebenaler’s house just upstream from Elba, MN, on a terrace above the Whitewater River. Flood 9/8/38. Top: Floodwater was up halfway on screen door. The men are pumping out the basement. Bottom: Siebenaler’s chicken house was moved off the foundation by the flood. Note sediment deposits in foreground. (Photo credit Soil Conservation Service [SCS].)..... 130

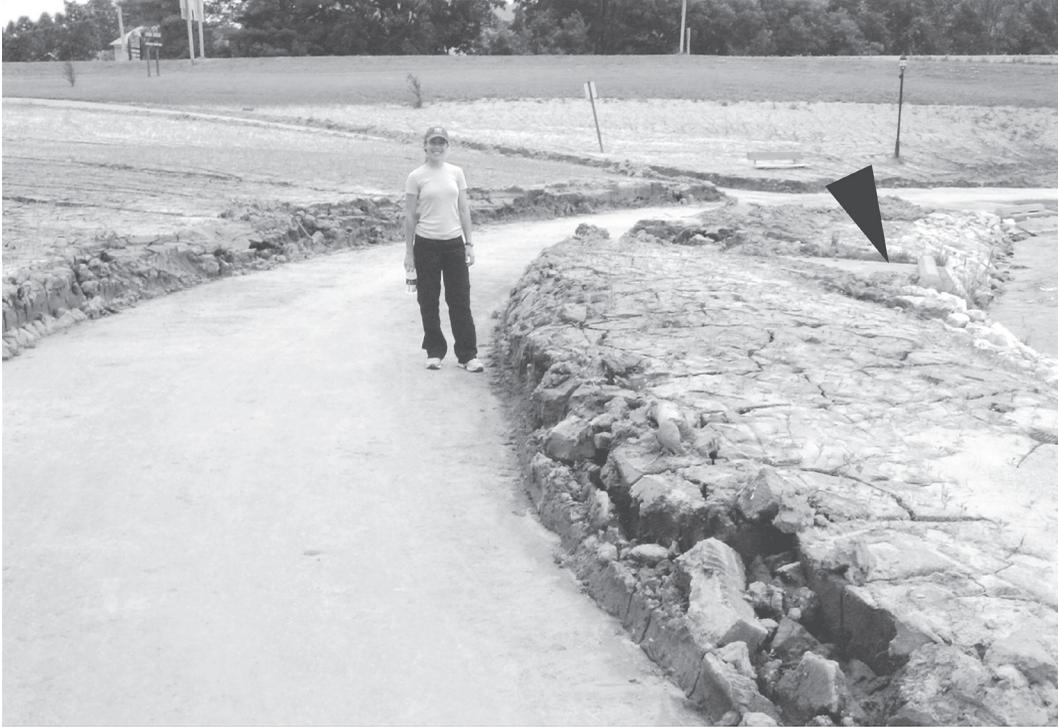
Figure 6.4 Aggrading “new” floodplain in Coon Valley Village Park. Floodplains were cut down to facilitate handicapped access ramps (arrow) to Coon Creek (seen on far right). Subsequently, the stream has attempted to rebuild its floodplains to the height dictated by the present flood regime, that height being about 6 ft (2 m). The elevation of the lowered floodplain is shown by the paved walk on which the person stands, and the recent deposits are up to 2 ft (60 cm) thick. However, the formerly retreating high banks have been stabilized with rock so that the previously expanding floodway is now stable and is decreasing in size. Photo made July 2008.

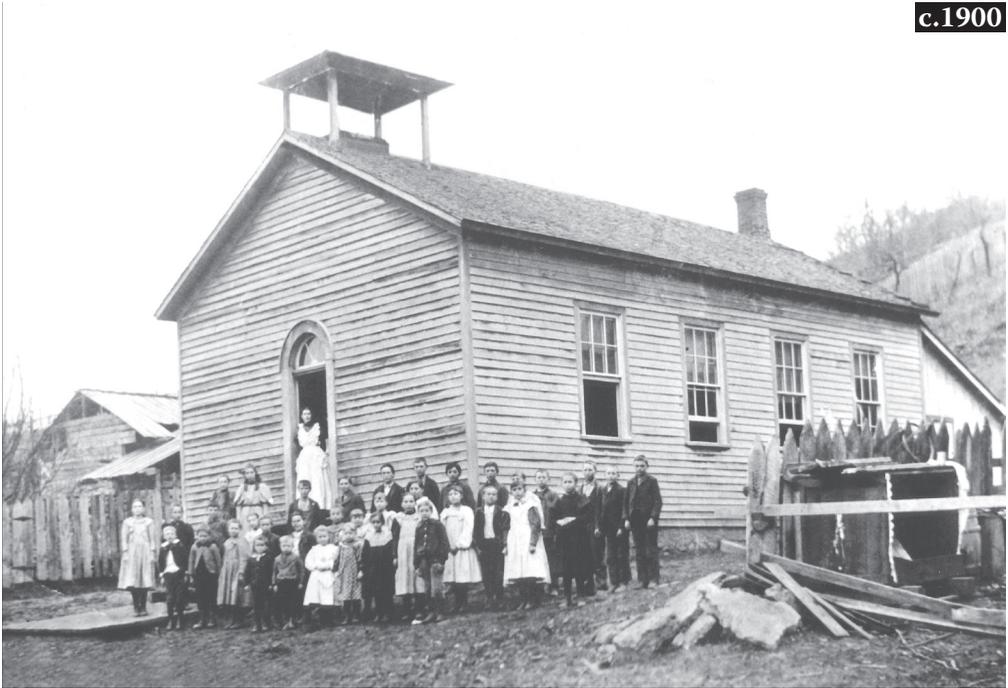
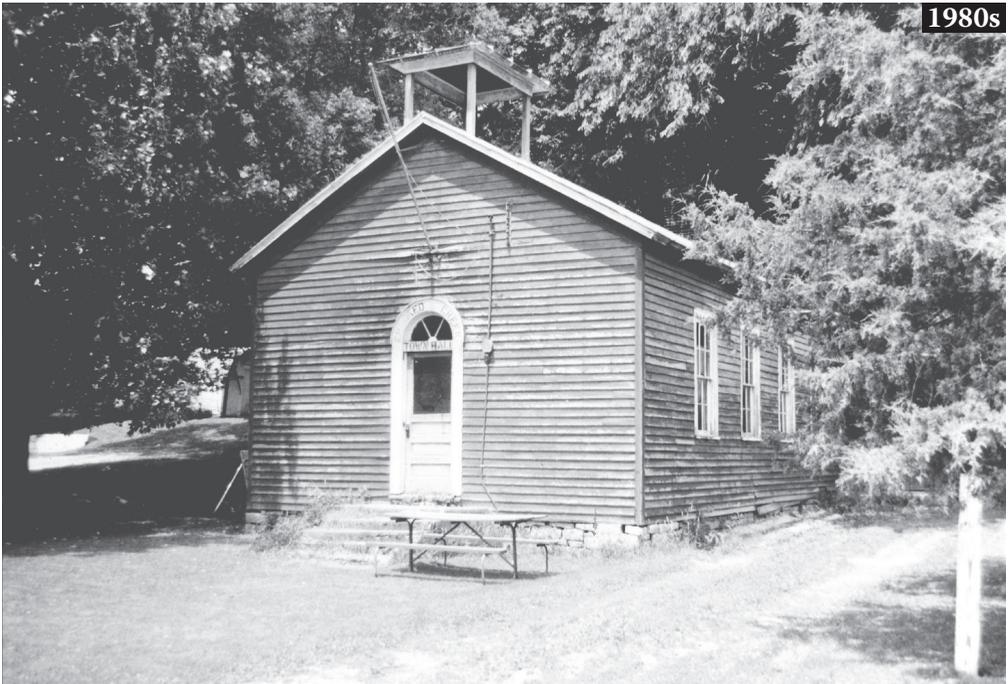
Figure 6.5 Freeburg, Crooked Creek, Houston Co., MN. Crooked Creek Township Hall. Top: Turn of century, photo made from road. Viewer's eyes are at a level about 4 ft (1.2 m) below the bottom of wooden siding on the building. Bottom: Again standing on the road, 1980s. Viewer's eyes are level with bottom of first board below windows. This suggests that road is now about 8 ft (2.5 m) higher.

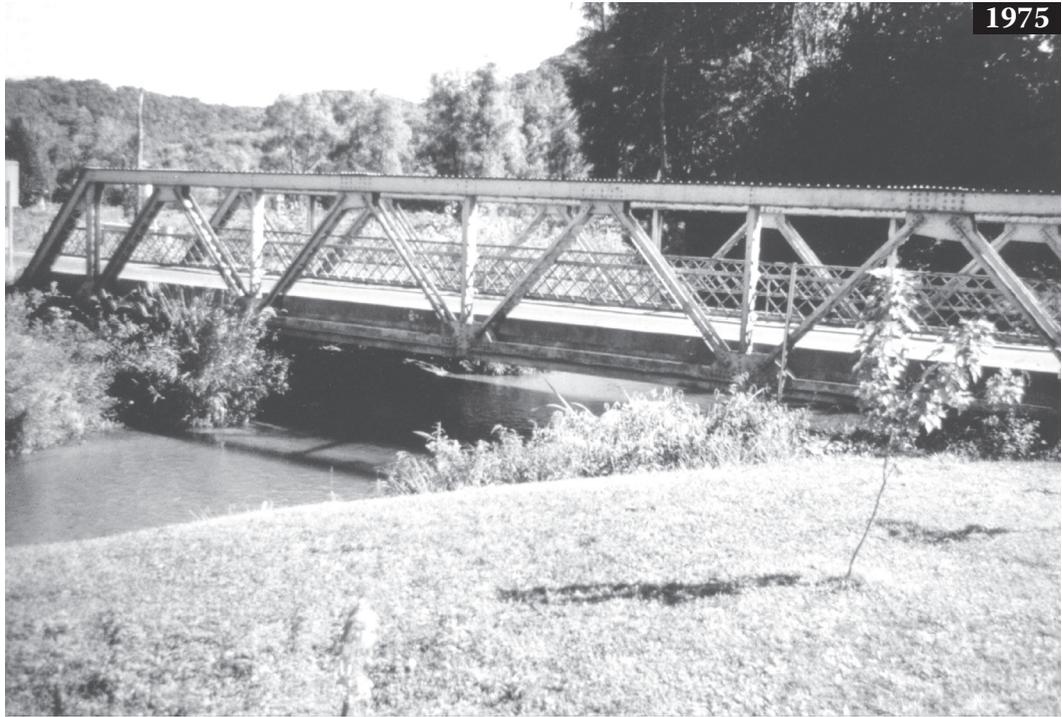
Figure 7.4 Continued 1975: Replacement bridge at the same site as above, looking southeast (upstream). The newer bridge sat about 1 ft (30 cm) higher than the old bridge but had only about 4 ft (1.2 m) of clearance above the water in 1977. The 2011 water level here is 10–12 ft (3–4 m) higher than in 1914.

Figure 7.4 Bridge over Coon Creek on Mill Street in Chaseburg just below auxiliary dam (seen in background), looking southwest (upstream), June 1914. Note rock shoals below dam. The sills of the bridge were about 13 ft (4 m) above the water. For locational reference, note Lutheran church in background. 1975: Replacement bridge at the same site as above, looking southeast (upstream). The newer bridge sat about one foot (30 cm) higher than the old bridge but had only about 4 ft (1.2 m) of clearance above the water in 1977. The 2011 water level here is 10–12 ft (3–4 m) higher than in 1914. 148

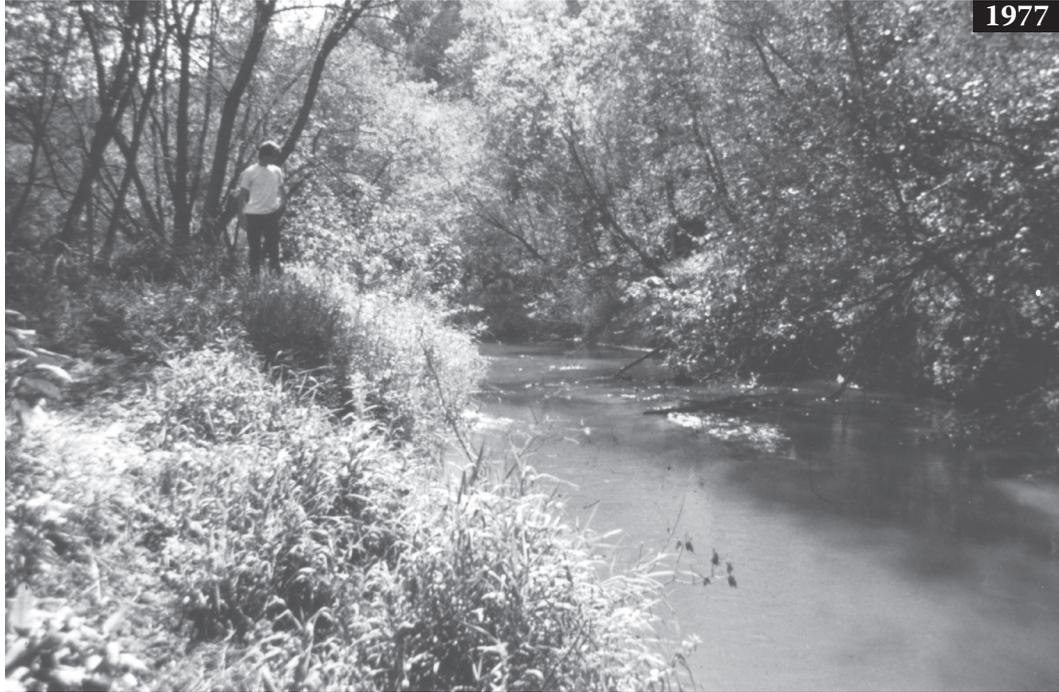
Figure 7.5 (Continued) 1977: All has been buried in floodplain. The person is 6 ft (2 m) tall. (Continued)

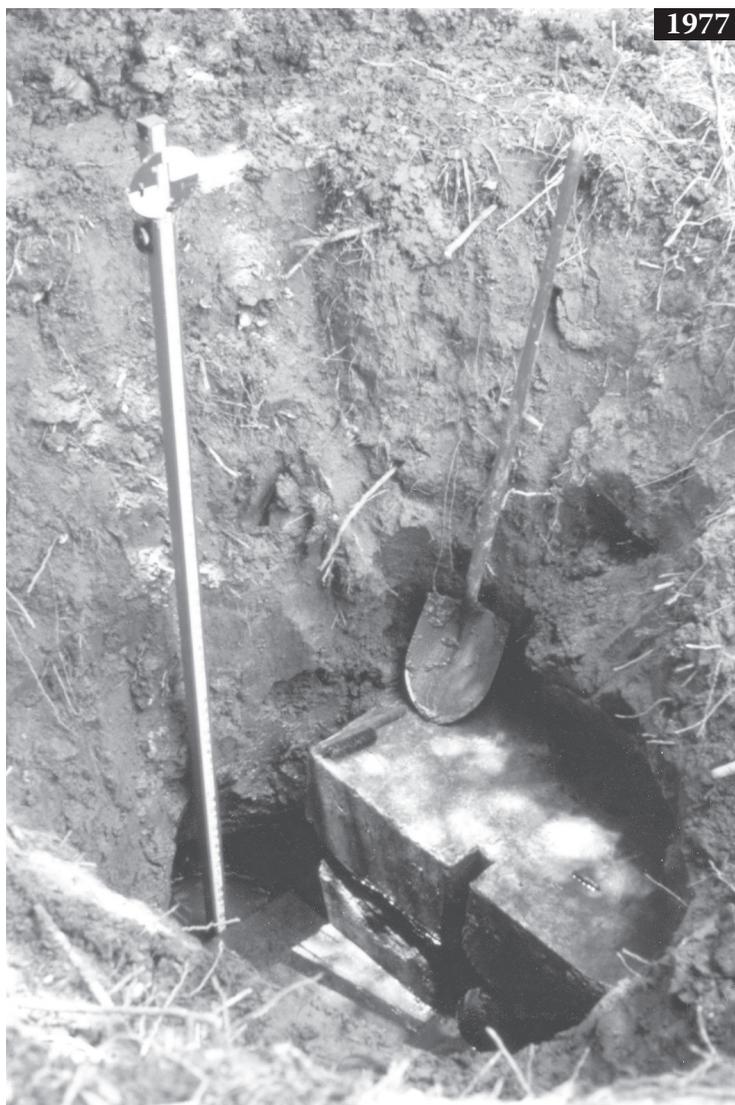
Figure 7.5 (Continued) 1977. Rectangular pier to hold flashboards (seen in the 1946 photo), excavated 1977. An elevation placed on the dam in 1932 tied into earlier surveys by the WI Dam Commission and allowed reconstruction of village elevations back to 1914 (Figure 7.2).

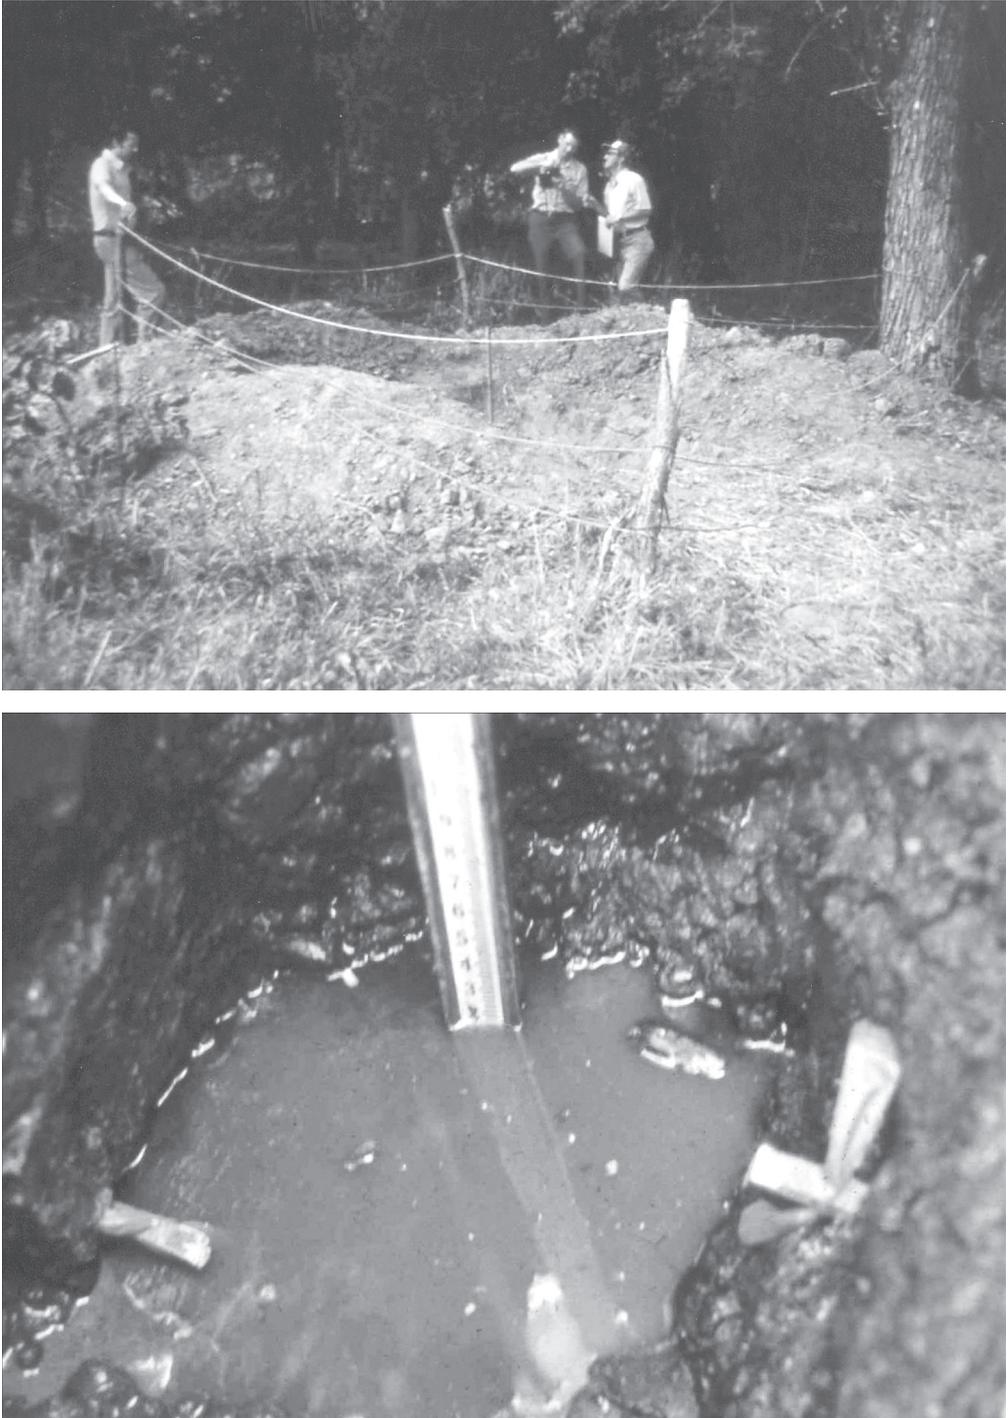
Figure 7.6 Martiny house, west of Main Street, Chaseburg, refer to Figure 7.2. Top: Excavation of foundation, August 1975. The vertical pipe marks the spot. Bottom: Base of excavated foundation, August 1975. Flag on left marks base of foundation. Flag on right marks contact of old, dark Mollisol and the lighter, highly stratified historical sediment deposited since 1903.

Figure 7.6 Martiny house, west of Main Street, Chaseburg, refer to Figure 7.2. Top: Excavation of foundation, August 1975. The vertical pipe marks the spot. Bottom: Base of excavated foundation, August 1975. Flag on left marks base of foundation. Flag on right marks contact of old, dark Mollisol and the lighter, highly stratified historical sediment deposited since 1903. 154

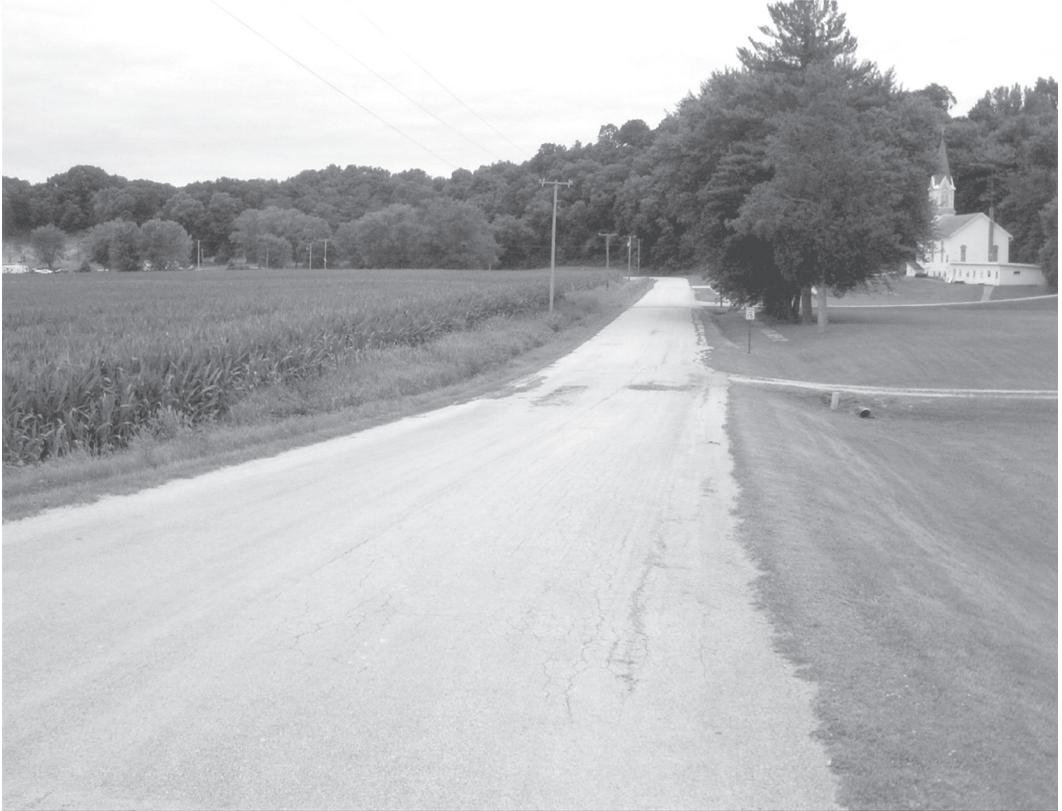
Figure 7.13 View down Linn Street in Elkport in 2009 (see arrow in Figure 7.12). The Lutheran church on higher ground to the right is the only building left. The remains of the other buildings lie beneath the sediment on the field to the left now growing corn. The whole village is now protected by a flood dike from which this photo was made.

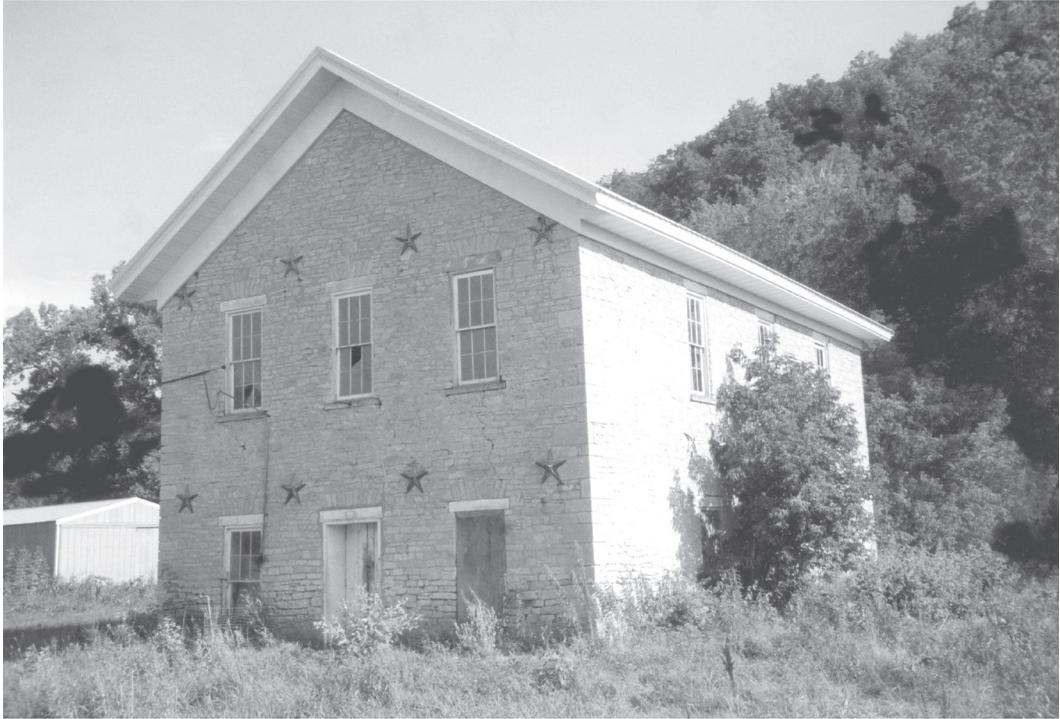
Figure 7.15 Village Creek. The schoolhouse, built in 1860, is the only old building left. Although in a higher part of the village, it has been buried 4 ft (1.2 m) so that downstairs windows are at ground level. (Photo credit: Nadine Kleinhenz, 2006.)

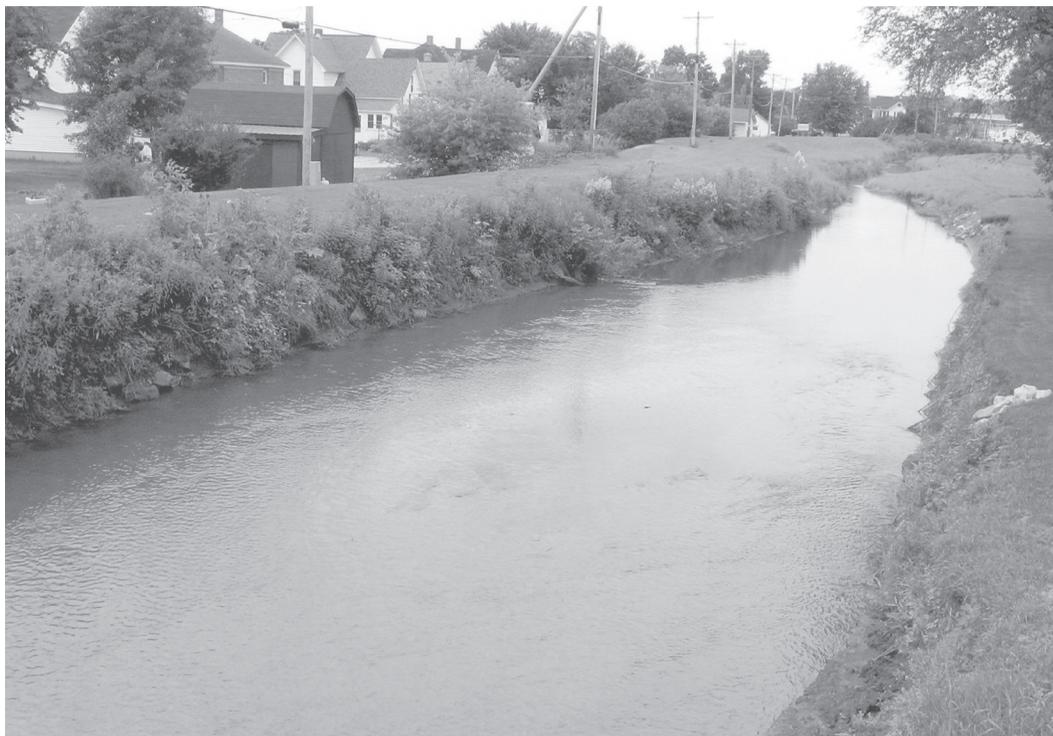
Figure 7.17 Arcadia, WI. Turton Creek at an old mill site, looking downstream towards the Trempeleau River, 2011. The stream flows along the north side of the town. Note that the water surface of the creek at normal flow is presently almost as high as the land on the other side of the flood dike. The dike to the left is about 4 ft (1.2 m) high. The fact that most of the houses in town had a basement suggests that the original water level was at least 10 ft (3 m) lower. Even the level of the millpond here would have been considerably lower than the present level of the stream. Otherwise, it would have flooded the areas to either side and would have raised local groundwater levels. The higher present stream levels, including the Trempeleau River, just 2 mi (3 km) downstream from this site, have caused groundwater to rise and flood basements in the town.

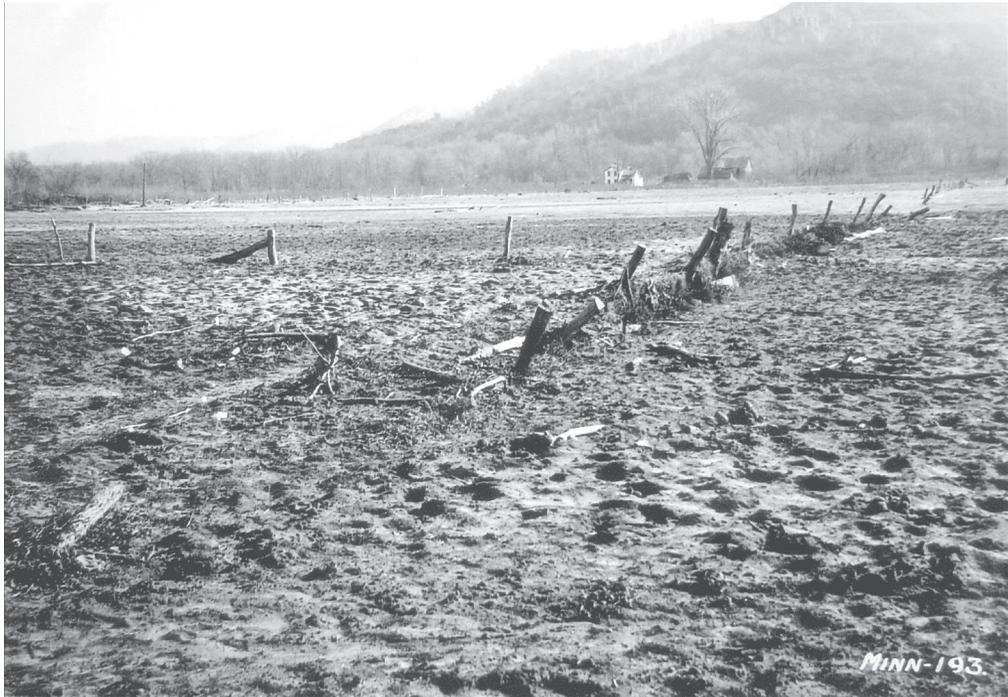
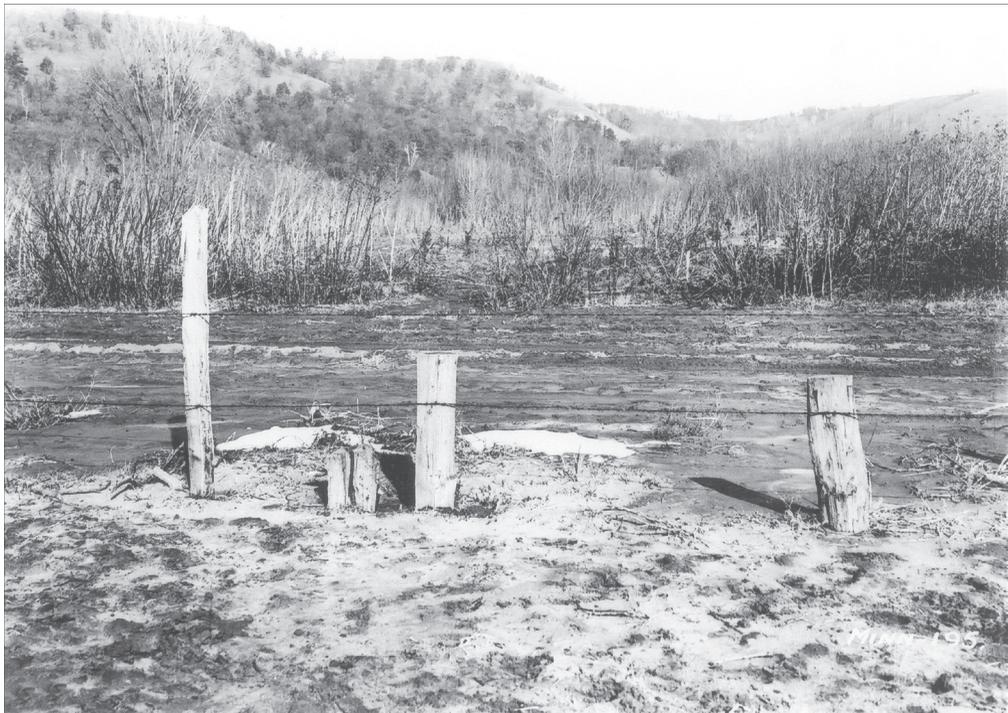
Figure 7.19 Floodplain covered with sandy sediment with buried and damaged fences, Whitewater River Valley, 1940. Note three generations of fences in lower photo. (From Trimble, S. and Lund, S., *U.S. Geol. Surv. Prof. Paper 1234*, 1982.)

Figure 7.19 Floodplain covered with sandy sediment with buried and damaged fences, Whitewater River Valley, 1940. Note three generations of fences in lower photo. (From Trimble, S. and Lund, S., *U.S. Geol. Surv. Prof. Paper* 1234. 1982..... 168

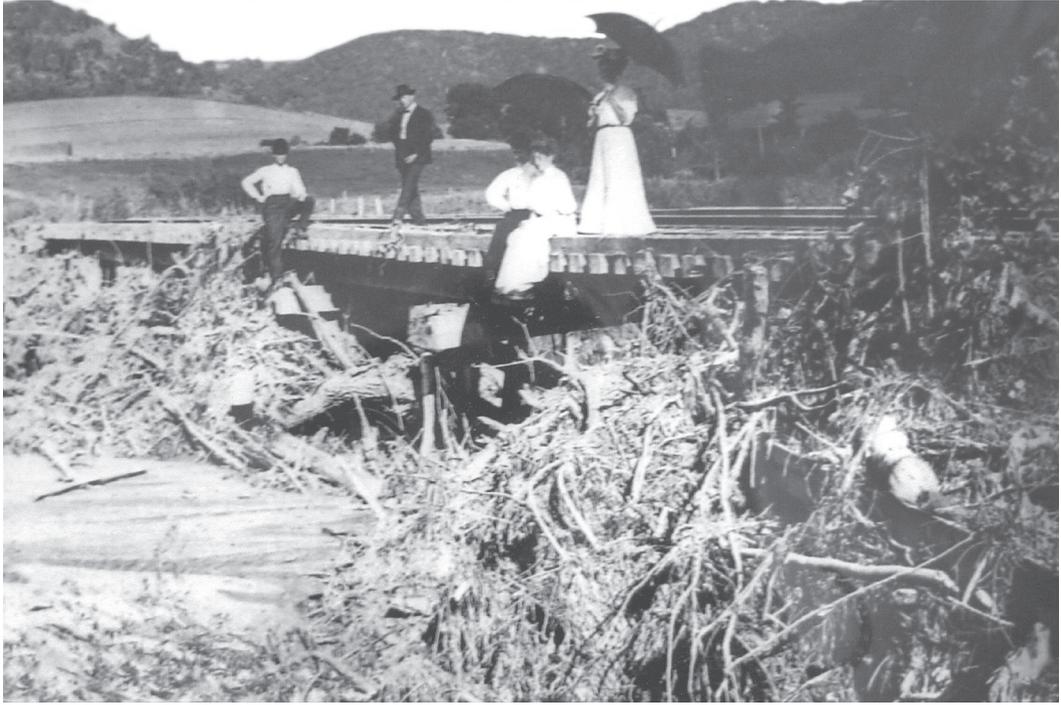
Figure 7.20 La Crosse and Southeastern Railroad, Coon Creek Valley, built 1904. Top: A railroad bridge seen near Chaseburg in the early 20th century, probably before 1915 based on the apparel. Note that the top of the rails is about 7 ft (2.2 m) above the channel, giving a small bridge opening. Note also woody debris from flooding partially occluding the bridge opening. Bottom: Surveyed cross section between Chaseburg and Stoddard. Railroad embankment was built here on edge of terrace about 10 ft (3 m) above the old floodplain. By 1938, the embankment was only 1–2 ft (30–60 cm) high. By 1974, it was completely buried. Note also the highway (left or north side of the profile), which had to be raised to stay well above the aggrading floodplain of Coon Creek (NW1/4, Sec. 29, T14N, R6W).

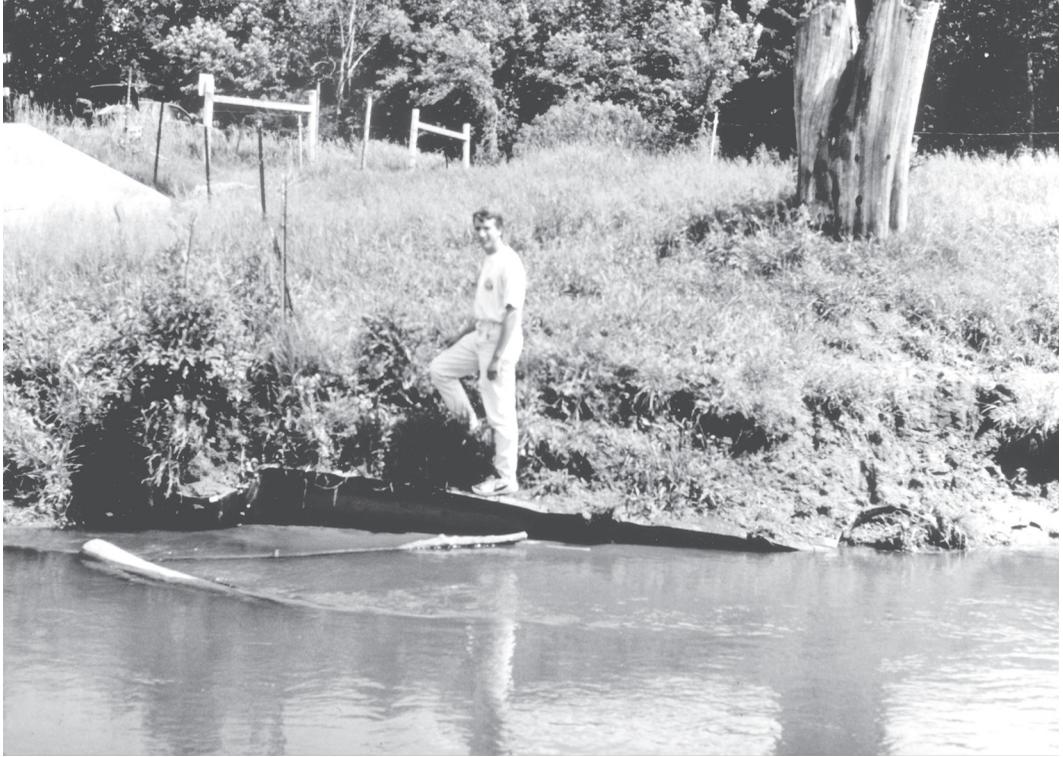
Figure 7.23 The south abutment of an old Dodson Hollow Road bridge over Coon Creek (SE1/4, Sec 22, T14N, R6W, Vernon, Co., WI). This bridge was replaced in 1926 as the creek rapidly aggraded, and the abutment was later buried in the floodplain. When built, probably in the early 1900s, this abutment was at least 10 ft (3 m) above the water. A small lateral shift by the stream in 1993 exposed the old abutment. The newest bridge (c. 1990) is seen to the far left.

Figure 7.23 The south abutment of an old Dodson Hollow Road bridge over Coon Creek (SE1/4, Sec 22, T14N, R6W, Vernon, Co., WI). This bridge was replaced in 1926 as the creek rapidly aggraded, was later buried in the floodplain. When built, probably in the early 1900s, this abutment was at least 10 ft (3 m) above the water. A small lateral shift by the stream in 1993 exposed the old abutment. The newest bridge (c. 1990) is seen to the far left. 174
