**HISTORICAL AGRICULTURE
AND SOIL EROSION IN THE
UPPER MISSISSIPPI
VALLEY
HILL COUNTRY**

STANLEY W. TRIMBLE

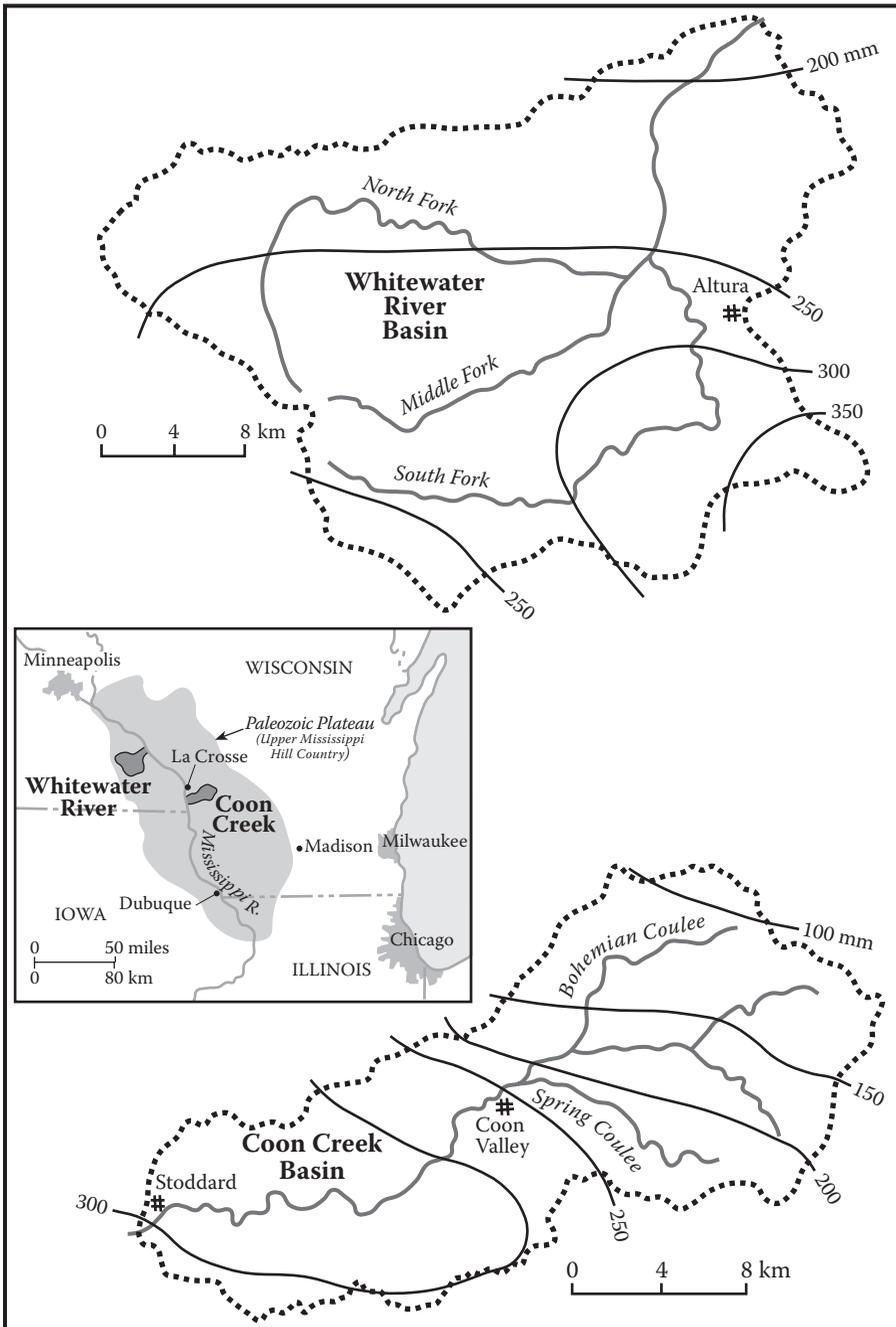
Figure 8.1 24-hour precipitation totals for the August 18–19, 2007 storm for Coon Creek and the Whitewater River. 1 in. = 2.5 cm. Data from National Weather Service.

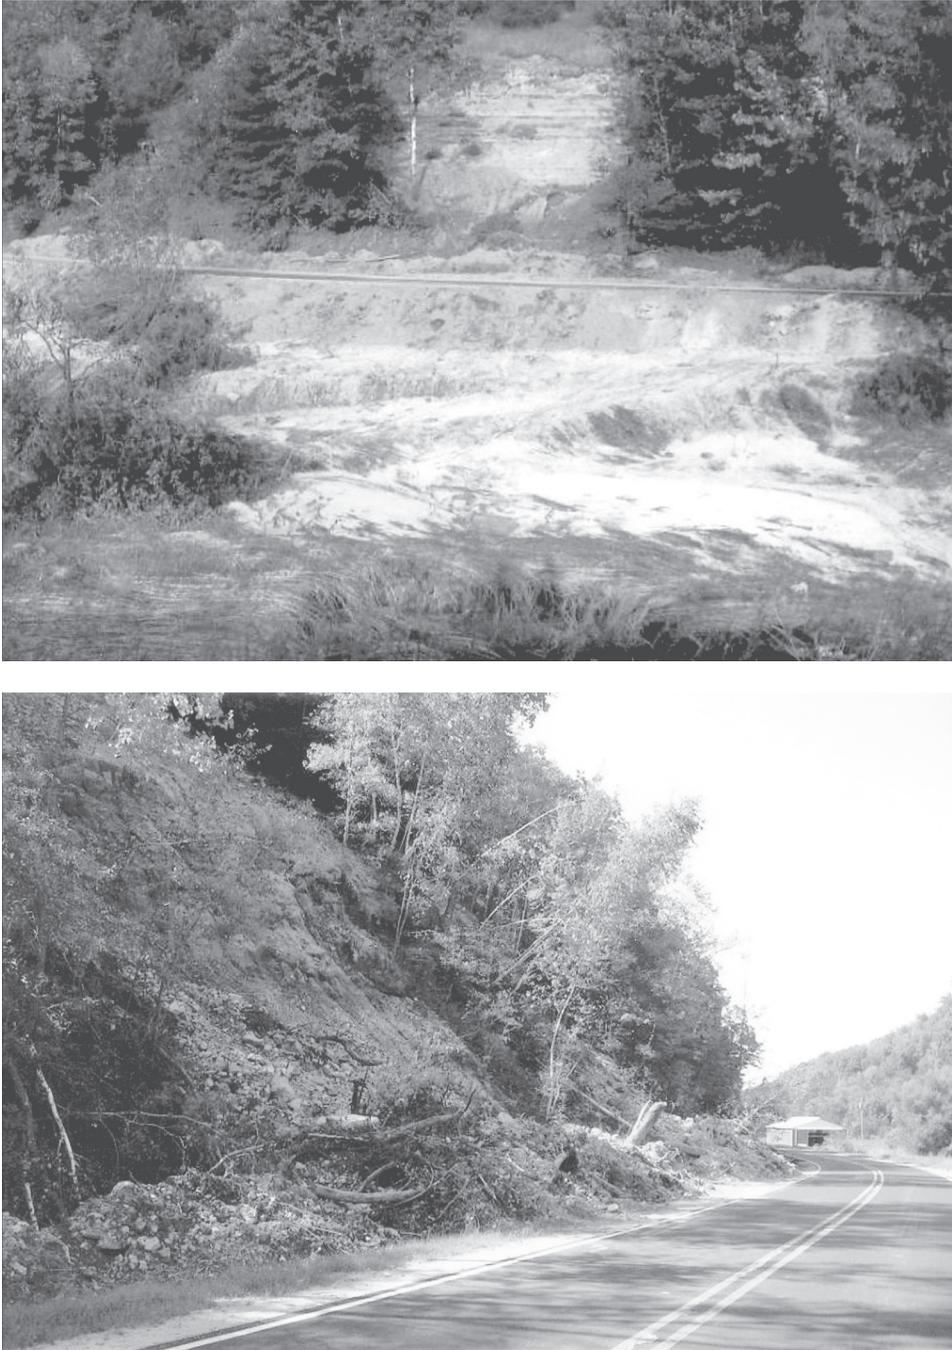
Figure 8.2 Mass movements from the August 2007 storm. Top: What appears to be a debris flow about 2 mi (3 km) north of Chaseburg, WI, at junction of Hohlfeld Road and County K, looking west from north end of bridge ($P > 12$ in. or 30 cm, NW1/4, Sec 21, T14 N. R 6W). Note that the sediment flow from the undercut road bank moved across the road, across the floodplain, and into Swain Creek. Bottom: Mass movement in Timber Coulee about 3 mi (5 km) north of Westby ($P = 6\text{--}8$ in., or 15–20 cm). (Photos credit: Edyta Zygmunt, 2–9 September 2007.)

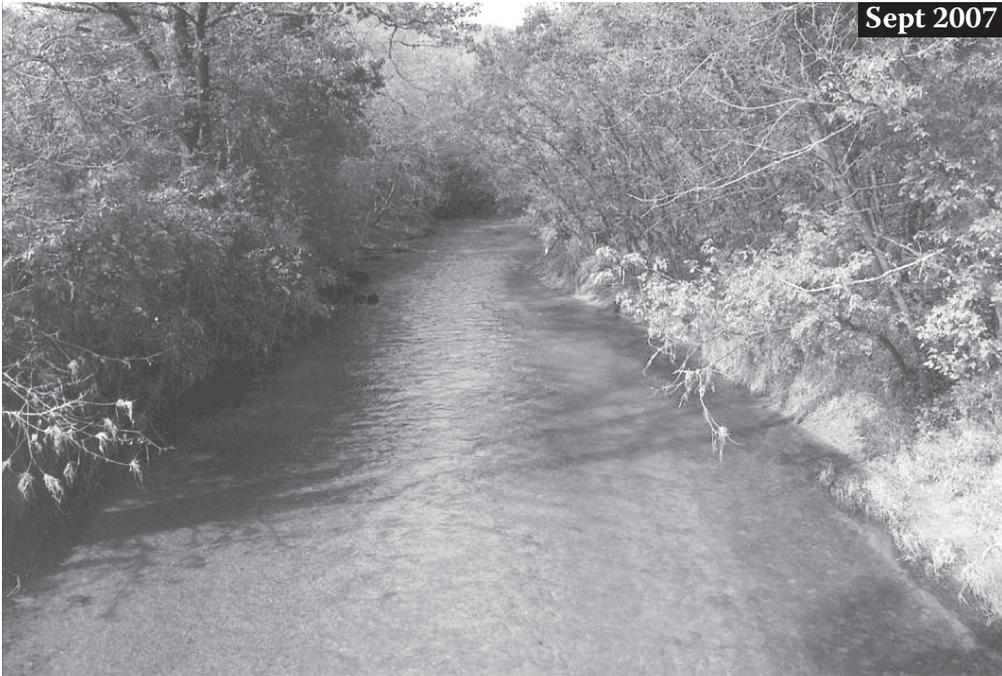
Figure 8.11 (Continued) September 2007, P = 9–11 in. (22–27 cm). (Photo credit: Edyta Zygmunt.)

Figure 8.11 North Fork of Whitewater River 1 mi (1.6 km) west of Elba, looking upstream from bridge as seen in Figure 3.12; note barn for reference. Top: 1940. Note disturbed condition of channel. Middle: 1975, condition was stable, and this has continued to the present. Bottom, September 2007, P = 9–11 in. (22–27 cm). (Photo credit: Edyta Zygmont.) 194
